# A Master Conservation Plan for Bas Relief and Bas Relief Park

Provincetown, MA

December 2016

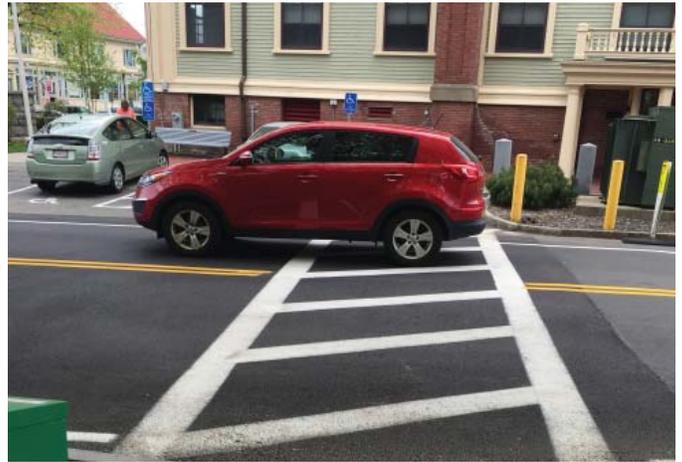
The park is accessed from Bradford Street and from painted crosswalks leading from Town Hall. The crosswalk paint is worn and should be refinished for improved visibility.

*Crosswalk from Town Hall*

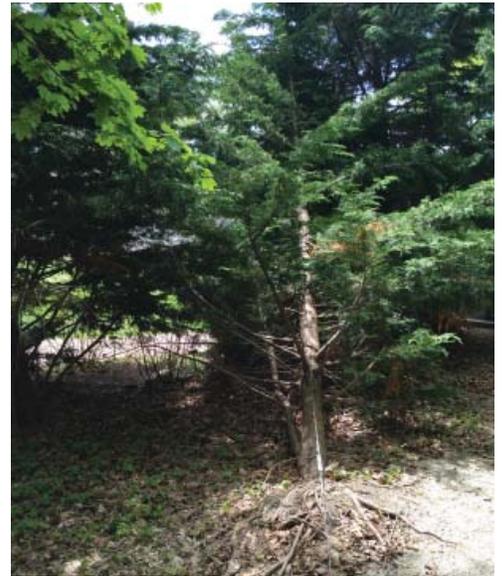
*Cabled Arborvitae adjacent to Bas Relief*

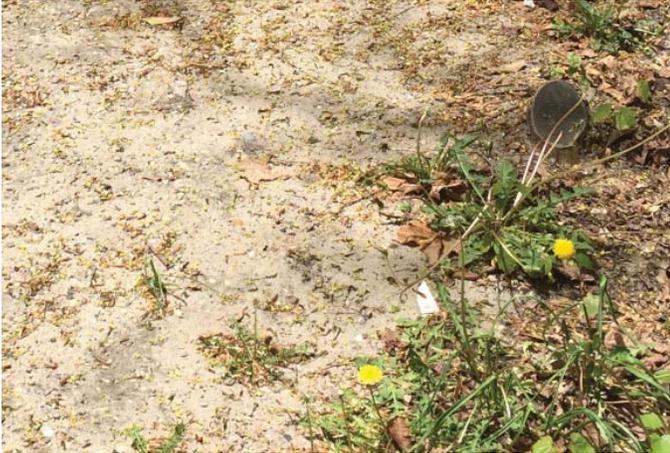
*Soils are Well Drained but Surface is Denuded in Some Areas*

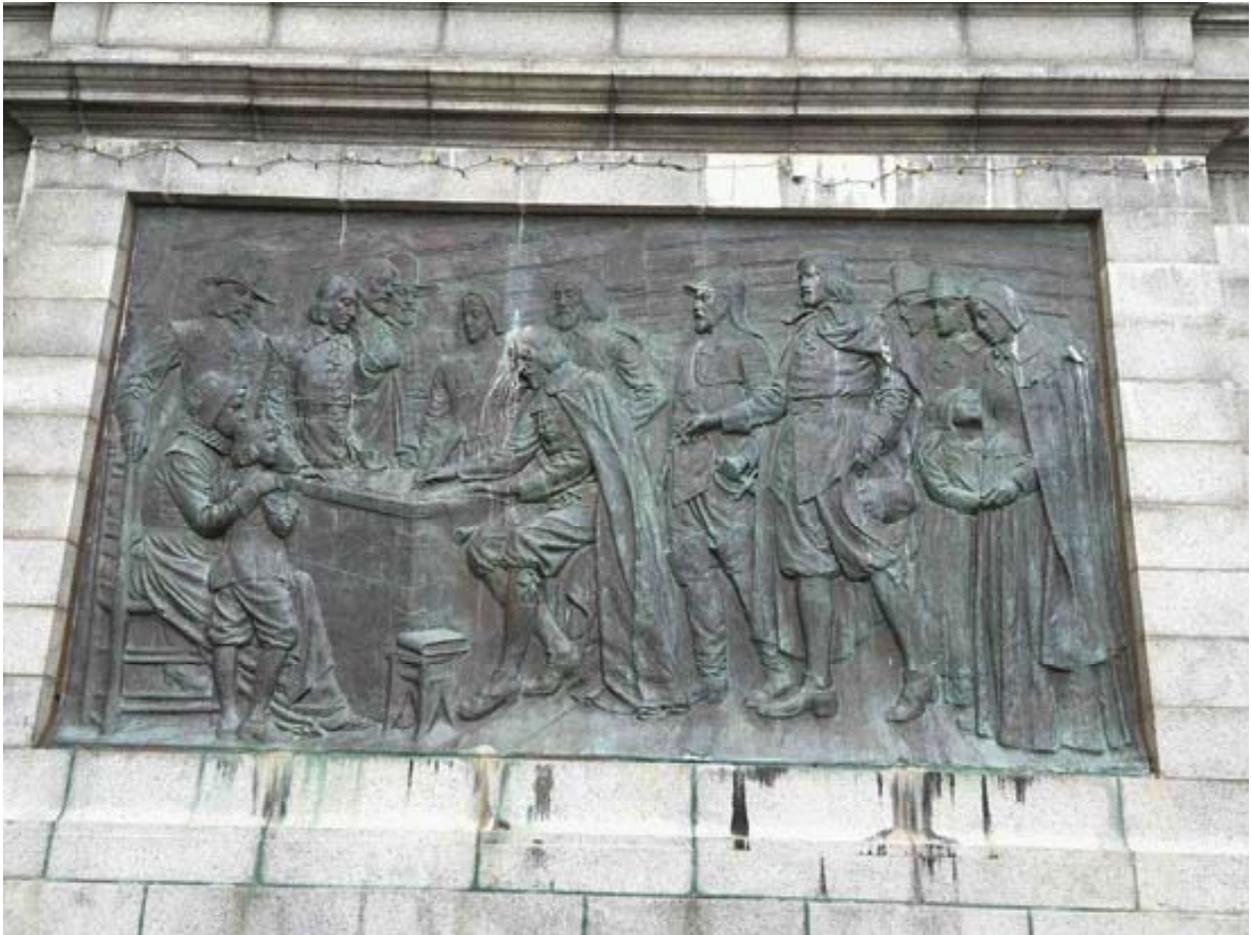
The Signing of the Compact is in overall good structural condition, with no cracks or metal deformations. However, the surface has severely suffered from past restorations, including complete overpainting with paint and bronze powders and loss of surface metal from an abrasive cleaning which has obscured some surface detail.

Numerous drip accretions of very hardened calcite from the original limestone mortar joints are present, as are other types of accretions and stains. There is a poor previous attempt at caulking the perimeter of the bronze with brown latex caulk, which is ineffective and unsightly.

There is copper corrosion caused by weather and salt air, including copper chloride (predominantly green-blue from salt), copper sulfate (predominantly green, from air pollution) and copper sulfide corrosion (predominantly black, also from air pollution). These corrosion products have combined with water and caused damage to the granite by staining the blocks and mortar below and adjacent to the bas relief.

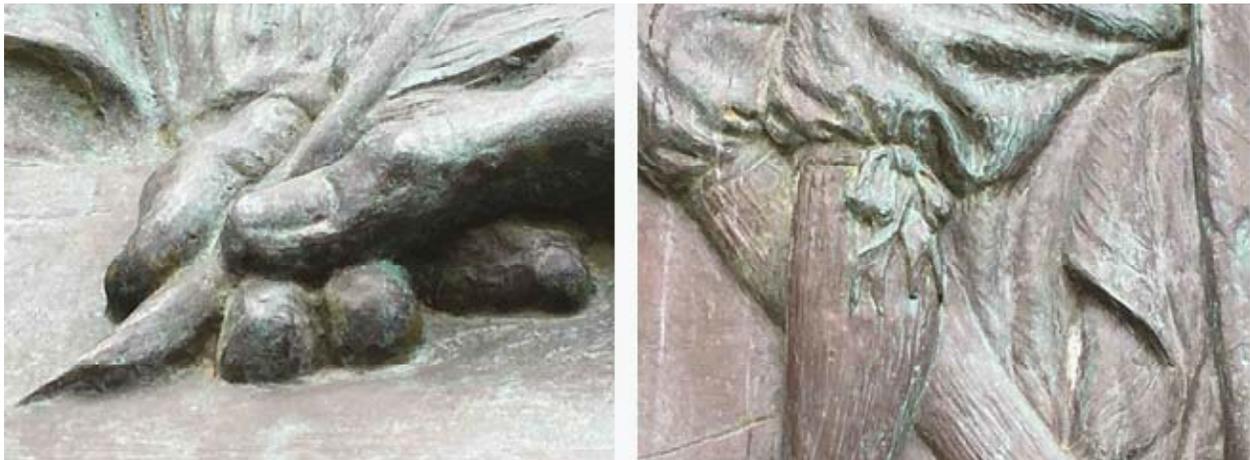
Left: Detail of William Bradford’s hand holding a quill pen. The surface has lost some definition from blast cleaning, and green corrosion is forming on upper surfaces.

Right: Detail of breeches with loss to patina and detail with more recent formation of green copper corrosion.

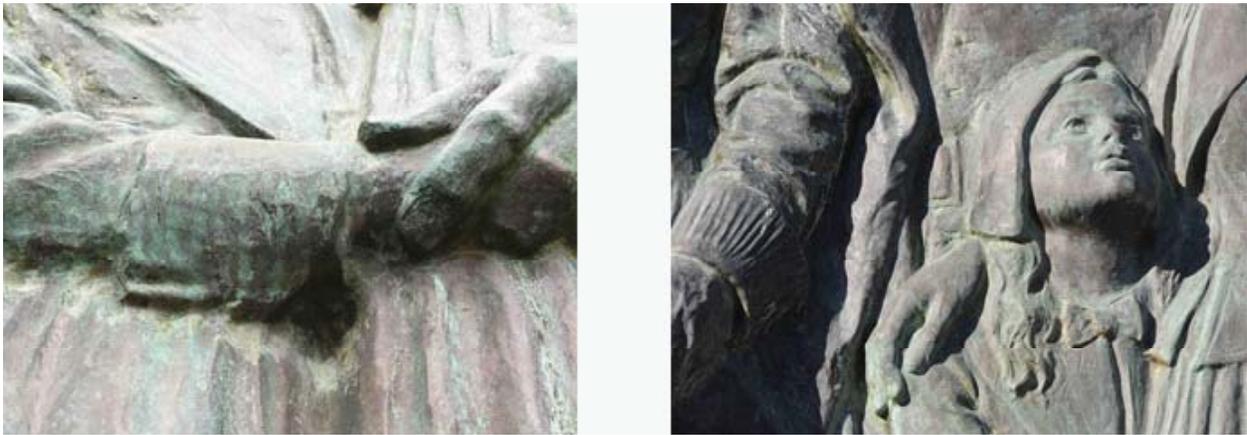
Left and right: details of patina loss and almost bare bronze from blast cleaning, and formation of recent green copper corrosion.

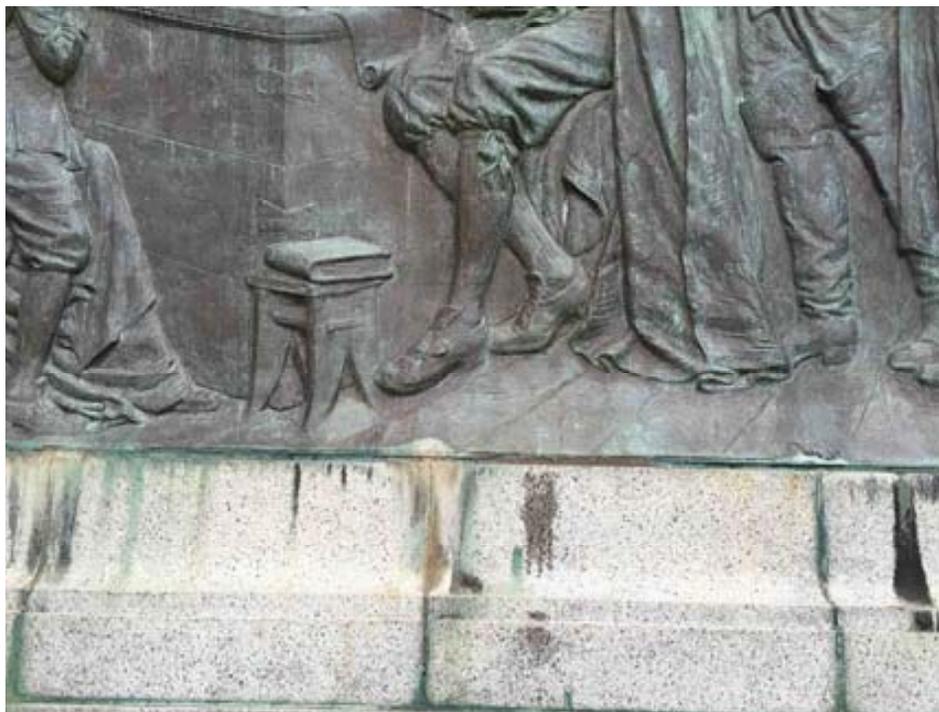
Above: Because of a lack of a protective surface coating and compromised lead packing, water run-off from the bronze has also stained the granite. Water has carried loose green and black corrosion products onto the granite blocks below.

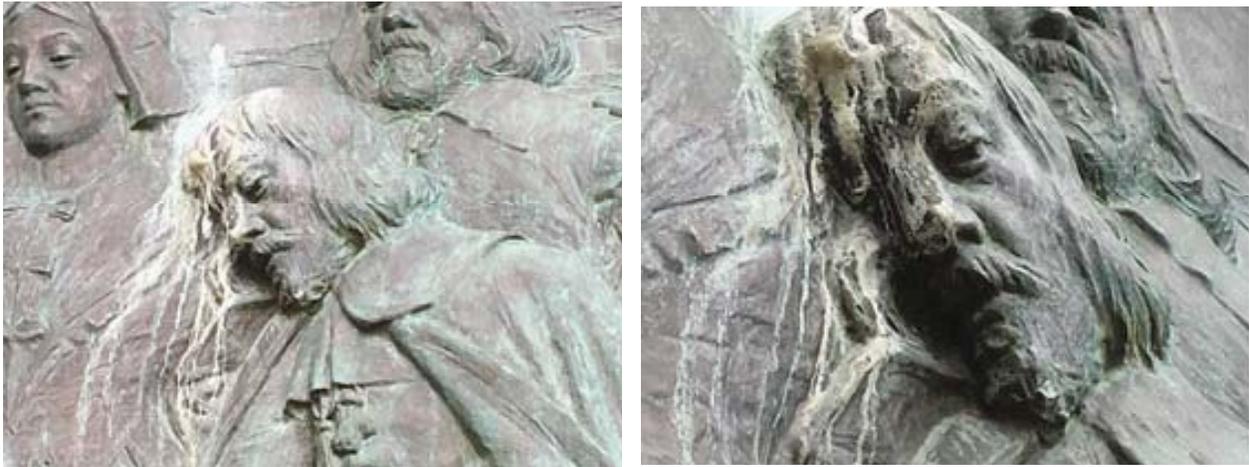
Hardened calcite encrustations have occurred due to deteriorating limestone mortar from the granite blocks. These have been present for a number of years, and therefore will be more difficult to remove.

Left: Calcite drips on the figure of William Bradford. Right: Detail of calcite encrustation.

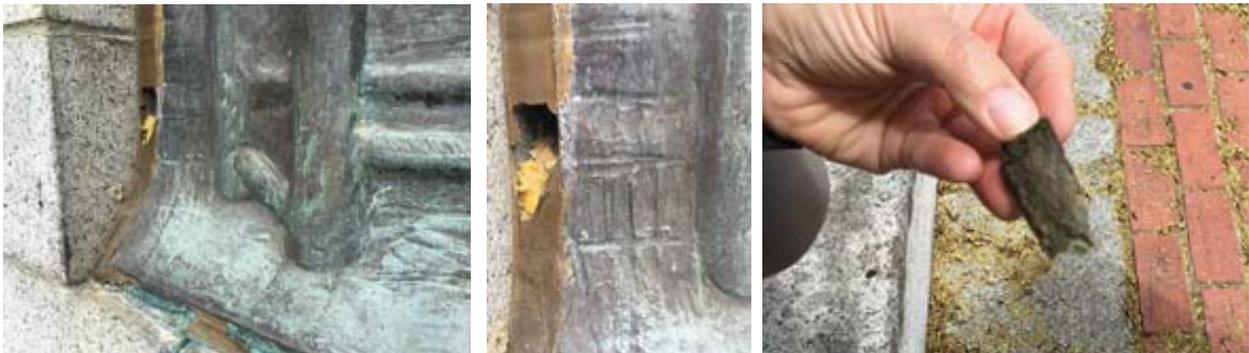
Left to right: The perimeter left and right of the edges of the bas relief have 1 ¼" gaps, and a 3/8" gap on the top and bottom. The very wide gaps on the sides are unusual, and suggest that the stone monument was not made to exactly fit the plaque (or the bas relief was not cast to the correct dimension).

A very unsightly recent repair to these gaps was done with a poorly applied brown latex caulk, some of which covers the original bronze surface. This brown caulk is flexible and easily punctured, behind which appears to be a loose stuffing of house insulation (fiberglass on the left and cellulose insulation on the right). Beneath the insulation are vestiges of oakum, an historic tarred fiber used for caulking in ship building. The depth from the bronze surface to the back of the granite is 3". The oakum was likely used to fill the wider gaps on the sides, while the more traditional lead sheet was used on the top and bottom to pack the spaces and prevent water infiltration.

These caulking and insulation materials are inappropriate and unstable and will need to be removed. They should be replaced with new packed oakum and polymer modified mortar for the sides, and historically appropriate lead sheeting for the top and bottom edges.

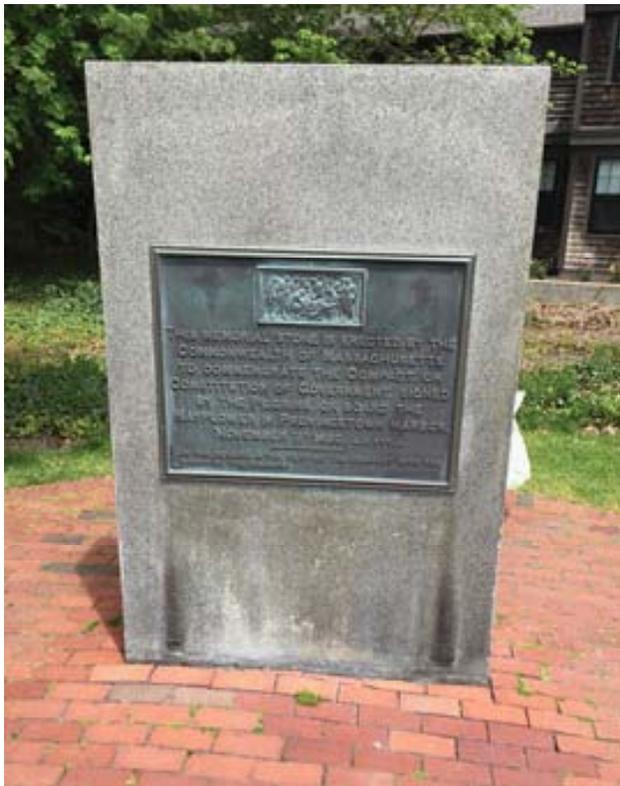
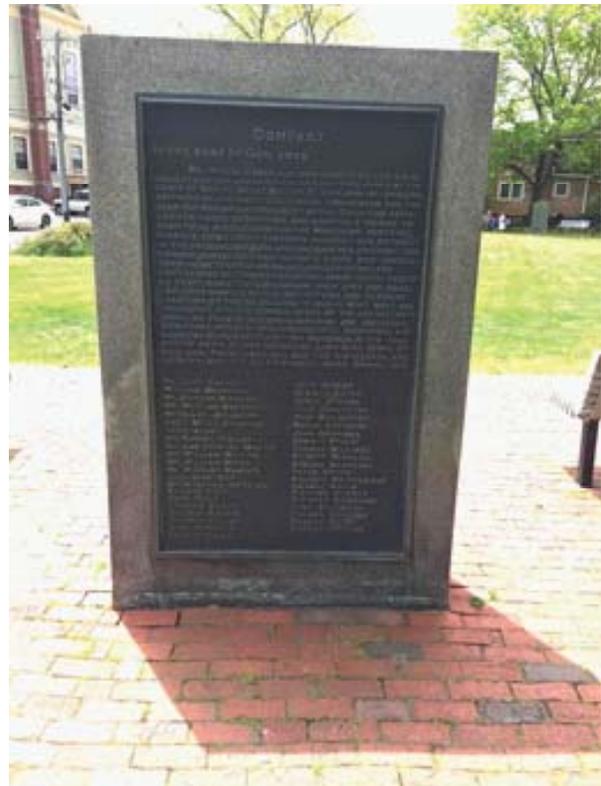
Left: secondary plaque on granite plinth to the right of the Bas Relief monument. The plaque is secured to the plinth. Water washing over the surface has picked up soil and corrosion products and to cause stains on the granite below. There are remnants of red crayon graffiti on the front of the plinth below the plaque. A protective coating on the bronze will prevent water run-off. Right: plaque on reverse with list of names of those who signed the Mayflower Compact.

1. Photograph both plaques before treatment in high-resolution JPEG format.
2. Wash all surfaces of bronze with Professional's Edge Enzyme digester in water to remove bio matter.
3. Wash twice with Orvus detergent (sodium lauryl sulfate) in water, using soft brushes, and thoroughly rinse. Towel dry.
4. Apply painter's tape and plastic sheeting to protect the granite plinth during treatment.
5. Remove any remains of previous wax with lint free cloths and naphtha.
6. Repair all areas of patina damage with Sennelier Raw Umber dried pigment using Golden MSA as a binder, followed by 3 spray coats of Incralac in toluene.
7. After complete drying, wax all surfaces with Butcher's Bowling Alley Paste Wax and buff.
8. Photograph after treatment.
9. Provide written report with maintenance directions and all JPEG images individually labeled.

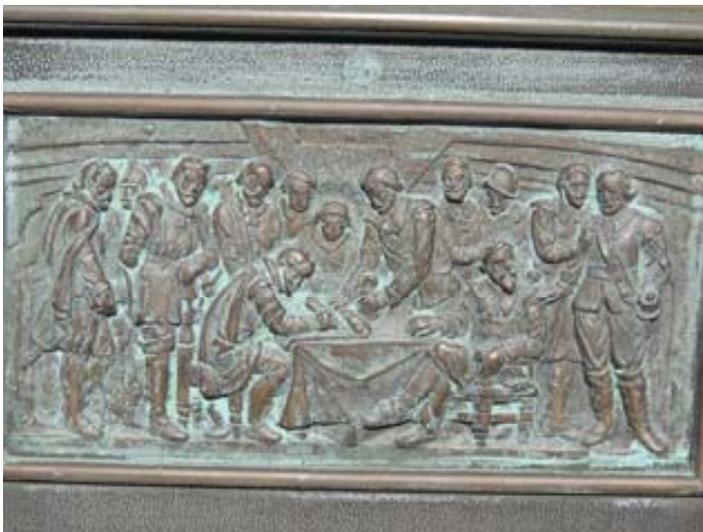
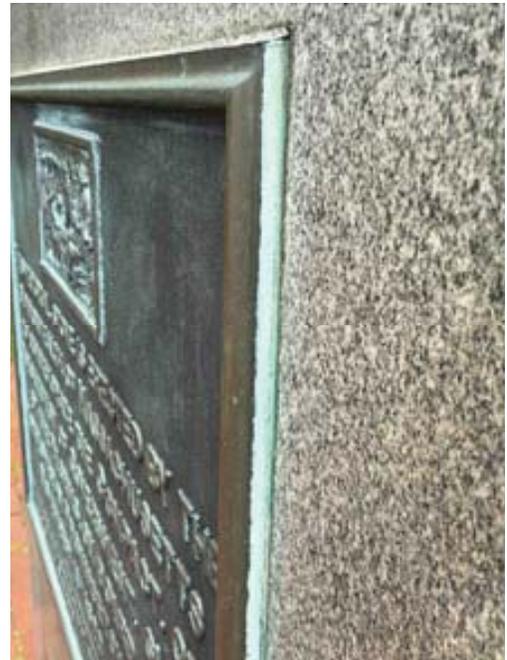
Left: detail of small secondary bas relief. Right: green copper corrosion on the sides of the front plaque due to the lack of a protective surface coating. Both plaques were originally dark brown.

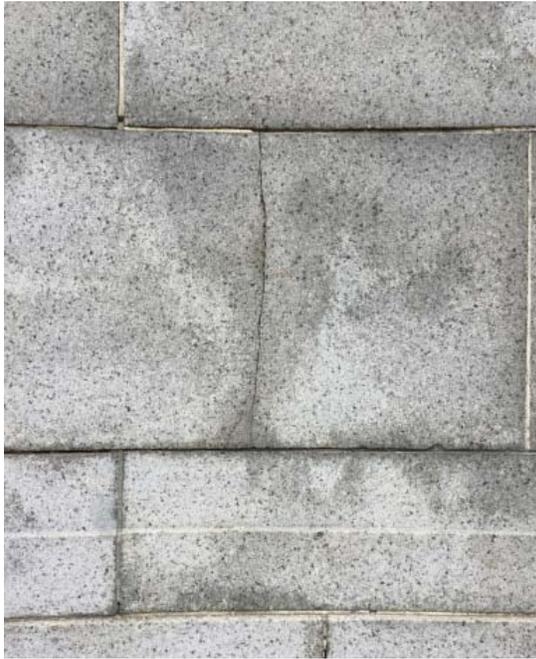
Fig. 2. Crack at east wall, north wing, at back of bench.

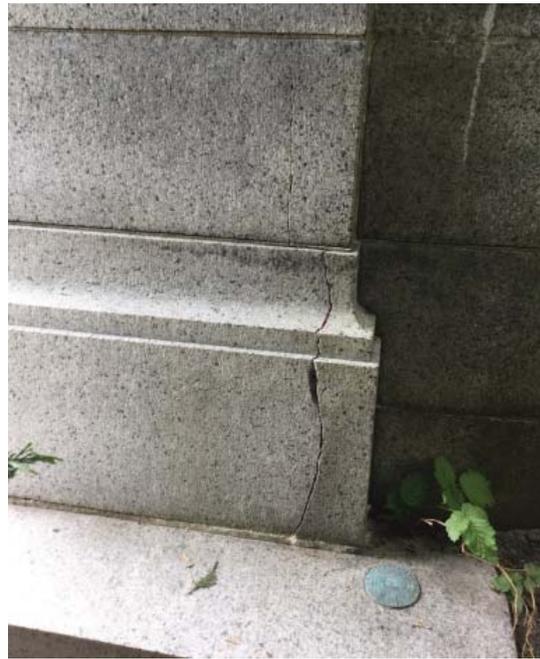
Fig. 3. Crack at back corner of north pier.

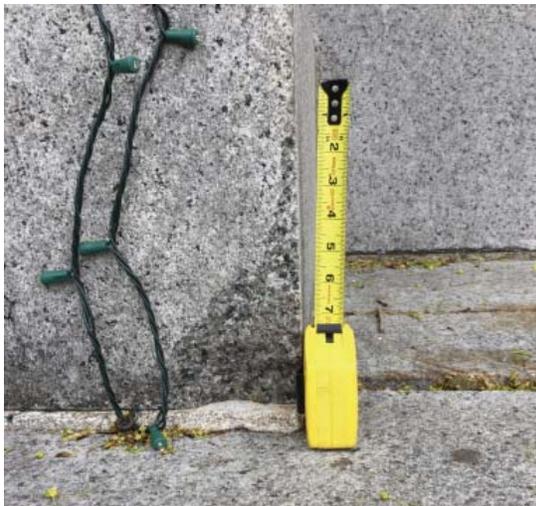
Fig. 4. Spall at southwest pier.

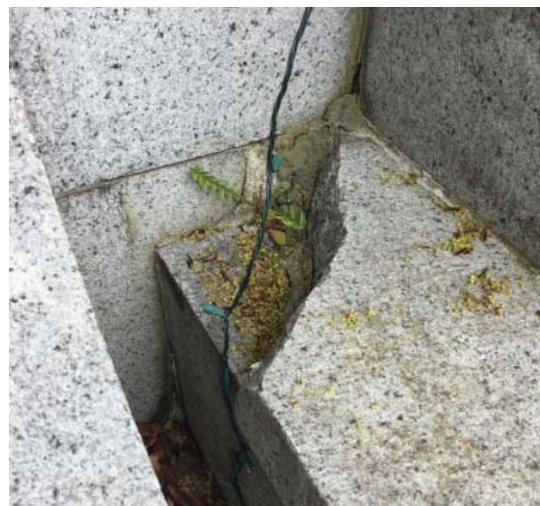
Fig. 5. Large spall to left of bas relief panel.

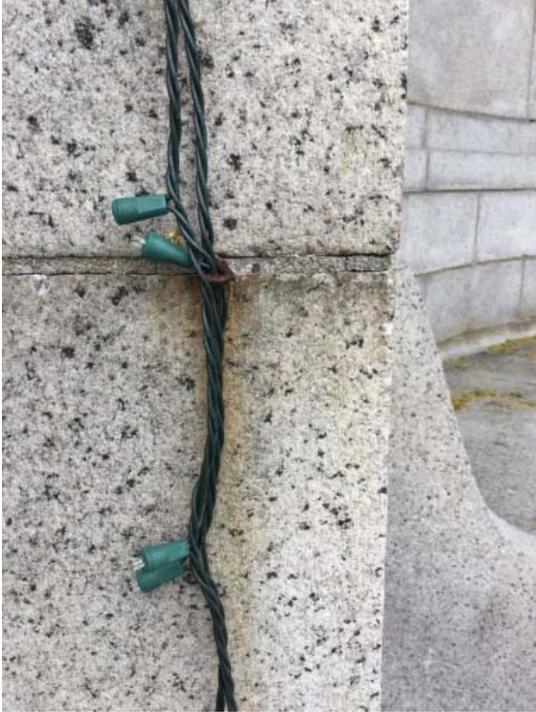
Ornamental string lights are attached to the monument by metal attachments and plastic fasteners affixed to the stone with epoxy. Both methods are causing damage to the stone. The metal attachments are rusting and causing staining of the surrounding stone. The epoxy has caused a stain where it was attached that will be difficult to remove.

Fig. 6. Ornamental light attachment with metal anchors. Note rusting.

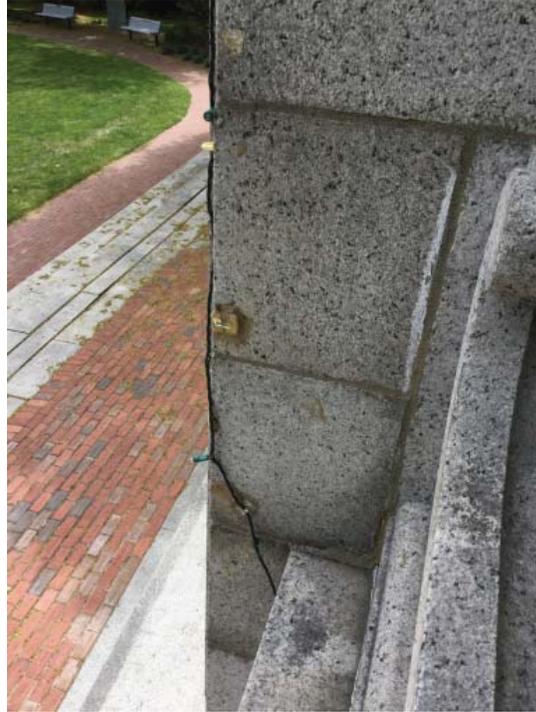
Fig. 7. Ornamental light attachment with epoxy anchor.

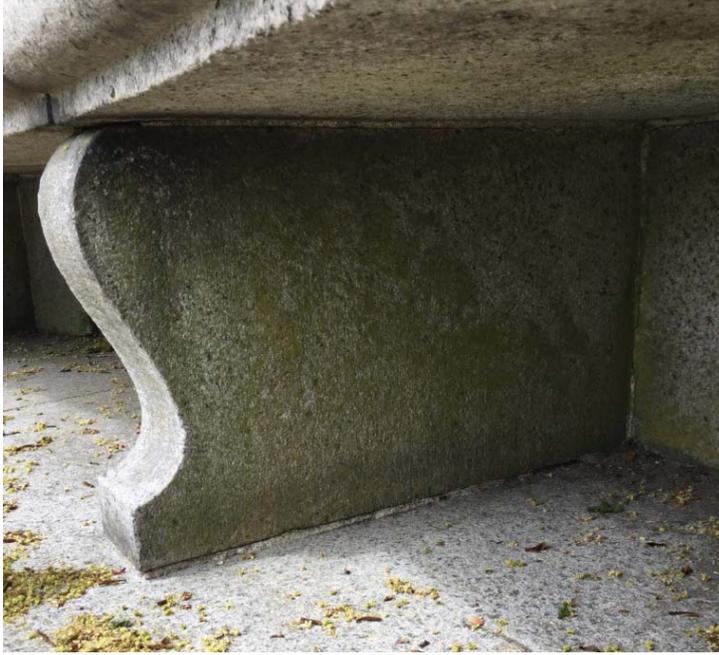
Locations that are not exposed to sunlight do not dry out adequately. Biological growth thrives in those environments and is occurring at the underside of the benches and on the back side of the structure. Biological growth can trap moisture, which can lead to accelerated weathering of the stone and mortar.

Fig. 8. Biological growth under bench. Typical condition along entire bench.

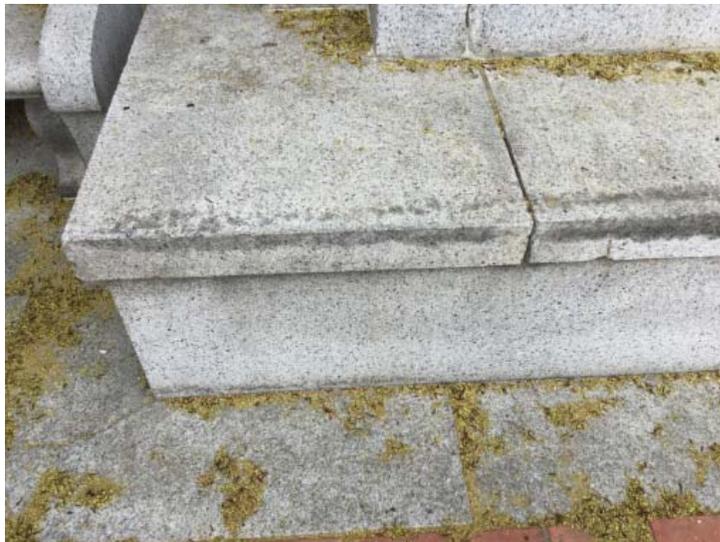
The front edge of the benches and the stairs have a dark hue to them, and the surface is slightly polished, or burnished. This is most likely caused by skateboards. The repeated skimming of the board and wheels against the stone polishes the surface over time.

Fig. 9. Polishing or burnishing of bench edge, possibly caused by skateboards.

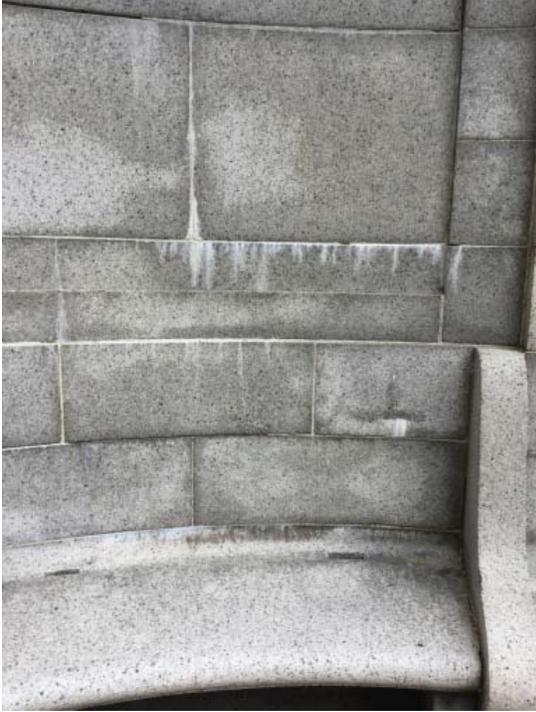
The white calcite deposits on the stone are caused by water infiltration, through open mortar joints, to the core of the structure. As the water exits the structure through lower mortar joints, the lime and cement washed out of the mortar. It is deposited on the surface of the granite, leaving the white encrustation that is seen in many locations.

Fig. 10. Calcite staining at back of bench, coming through mortar joint and crack in stone.

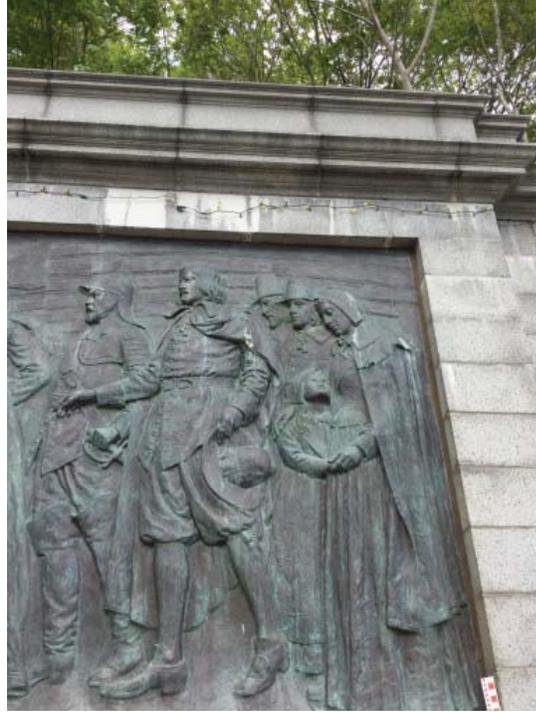
Fig. 11. Calcite staining above bas relief, coming through mortar joint.

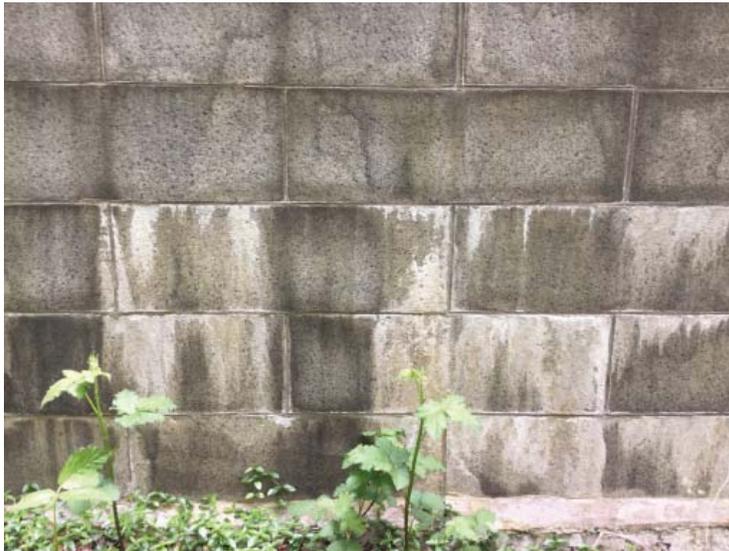
Fig. 12. Extensive calcite staining on back of monument indicating extensive water infiltration issues.

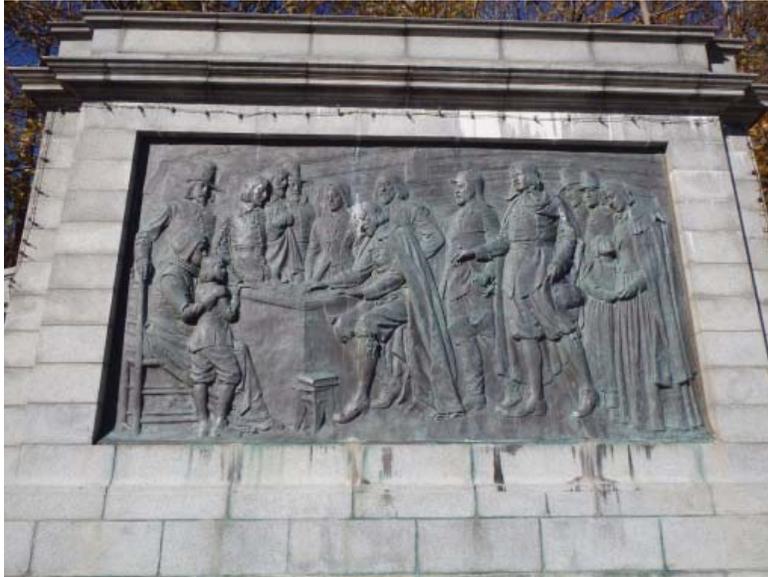
Water infiltration behind and over the surface of the bronze bas relief panel has caused bronze staining on the stone, below the bas relief.

Fig. 13. Bas relief showing bronze staining on stone.

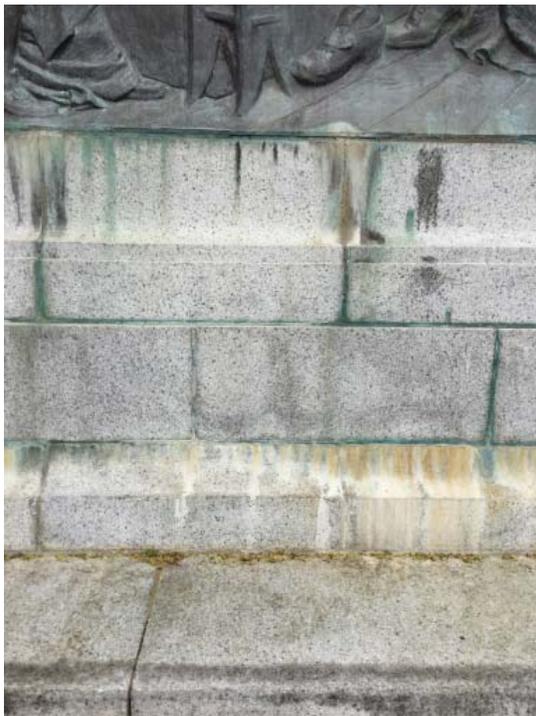
Fig. 14. Bronze staining below bas relief. Note staining of stone and mortar joints.

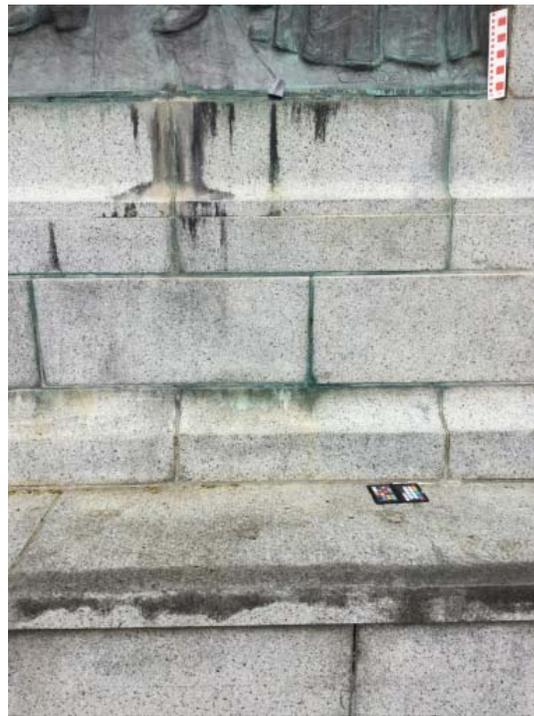
Fig. 15. Bronze staining below bas relief.

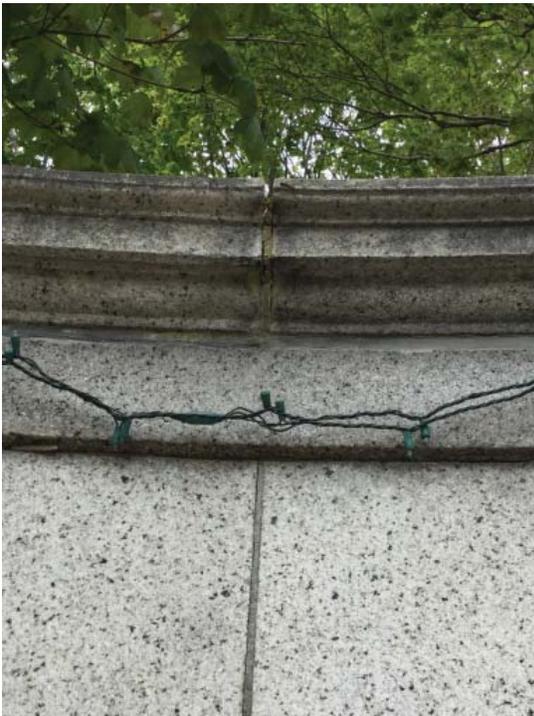
The mortar is in fair to poor condition, with many of the joints completely missing or deteriorated to the point of failure. Open mortar joints allow water to infiltrate the interior of the structure, accelerating the deterioration of the mortar and the stone. This occurs in several ways. As the water exits the structure, it washes the lime and cement components from the mortar, leaving behind a weaker mortar composed primarily of sand. In addition, the lime and cement washed out of the mortar is deposited on the surface of the granite, leaving the white encrustation (calcite deposit) that is seen in many locations. Water infiltration behind the bronze bas relief panel has caused bronze staining on the stone, below the bas relief. When water saturates the stone and mortar and the temperatures drop below freezing, the water trapped in the masonry expands as it freezes. This expansion has the force to spall or displace the stone. The location where most of the water is entering the core of the monument is through the mortar joints in the capstones.

Fig. 16. Open mortar joint at cap. Typical condition.

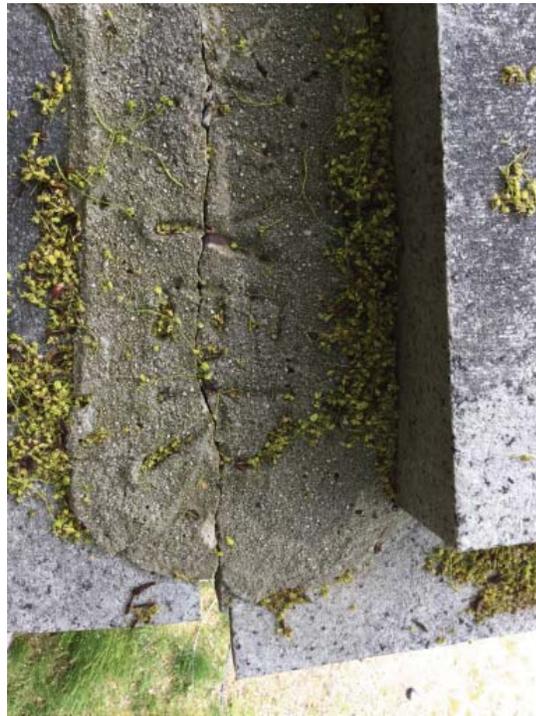
Fig. 17. Open mortar joint at capstone.

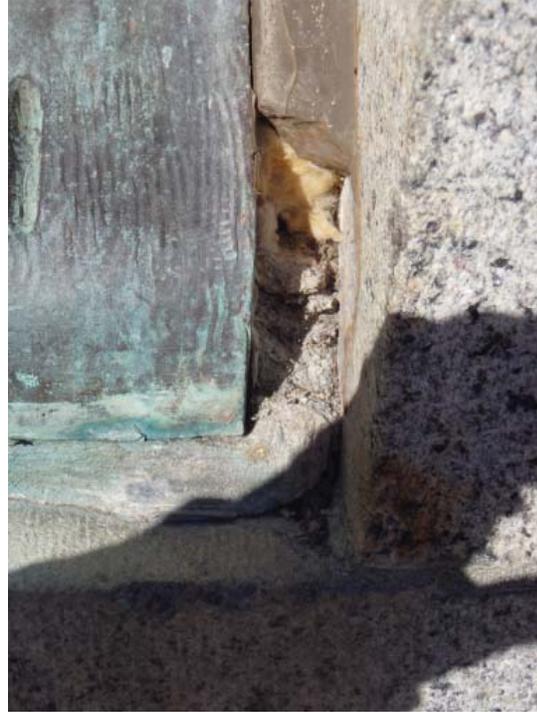
Fig. 17. Large vertical joint filled with insulation and mortar. Joint is over 1 inch wide in locations.

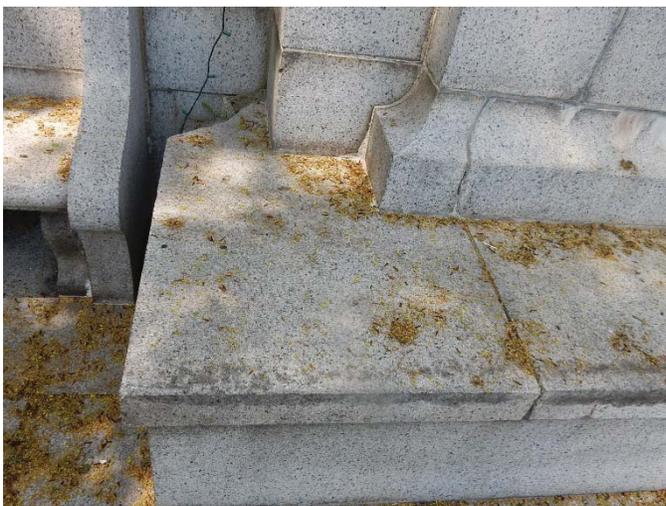
9. End of bench slab broken left side of center mass.

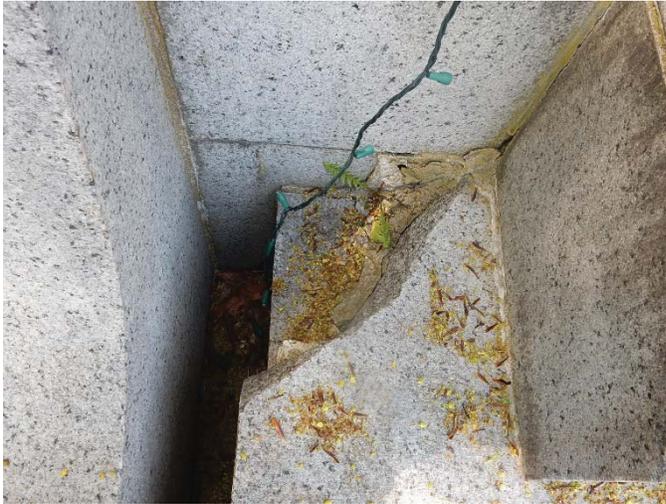
10. Broken bench slab (Photo 8) has the appearance of having been pried off the supporting stone under it. Most likely water seeped through the reentrant vertical joint into the bed joint of the bench slab. The water got trapped, froze in the winter, and thereby expanded prying at the slab.

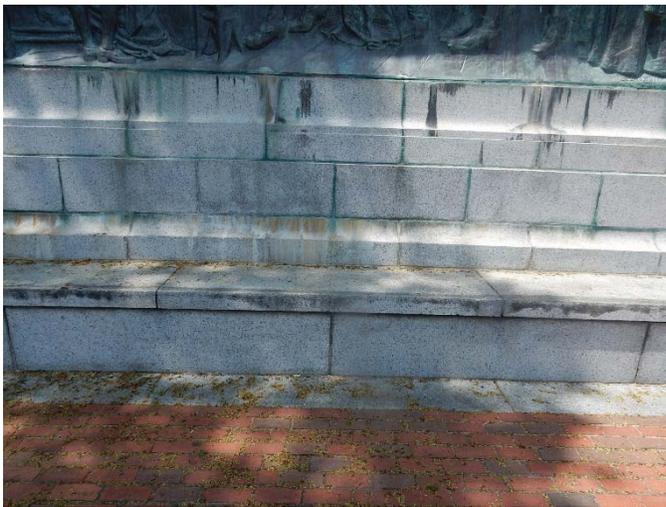
11. Discoloration under the plaque from copper oxides transported through the stone joints. Water seeping inside the joints is likely transporting oxides from the back of the plaque where the surface is unlikely sealed. The dark stains could be the result of mastics behind the plaque or carbonation of the granite.

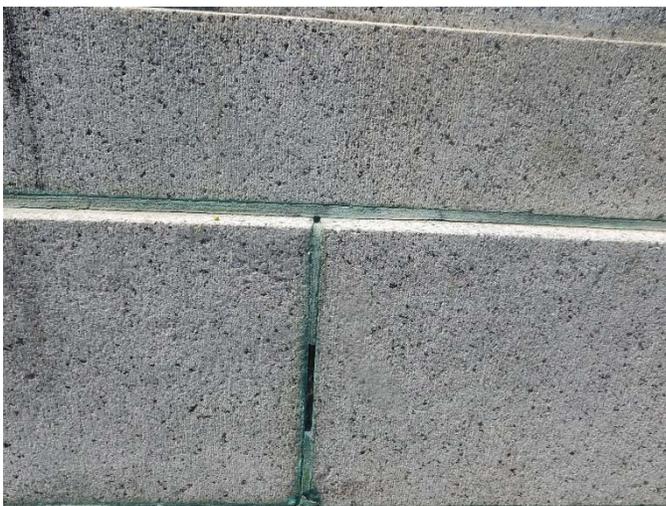
12. Close-up view of copper salts bleeding out of mortar joints. This suggests water is readily moving through joints.

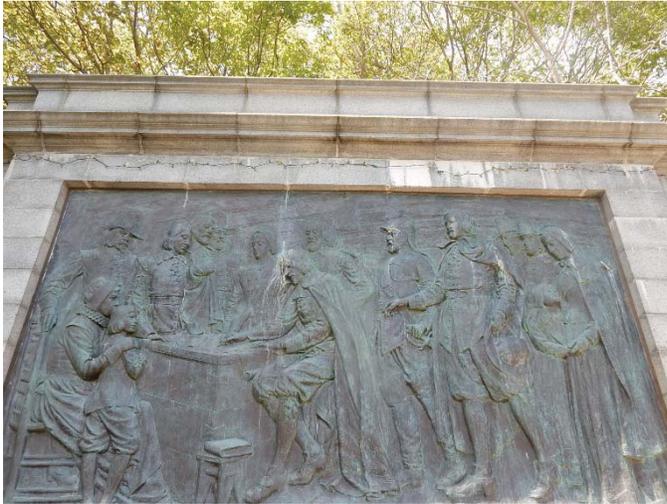
13. Salts are bleeding out of stone joints above the plaque. A large white stain looks more like a coating material that bled out of the underside joint of the water table.

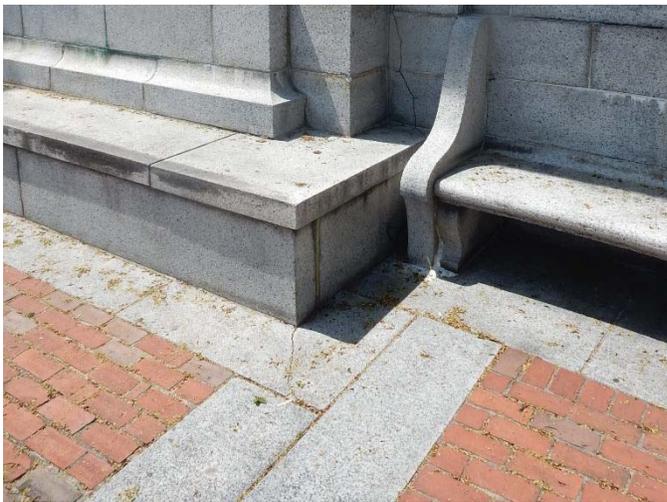
14. The paving stone under the bench corner is cracked.

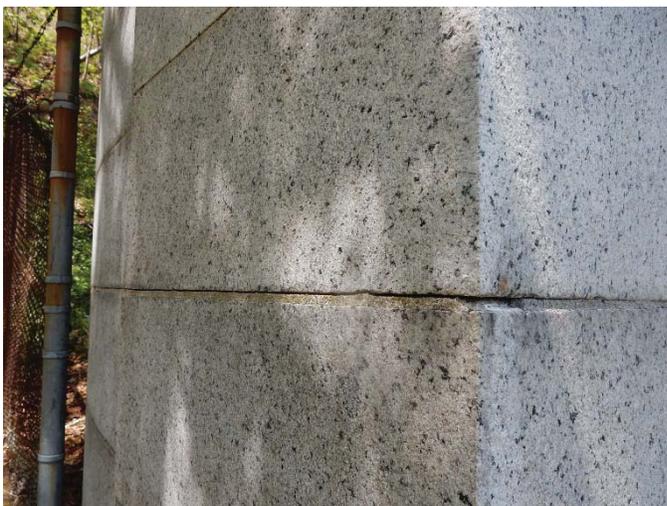
15. Close up view of the pilaster at the leftmost end of the left wing. The bed joint has a gap between the mortar and stone. This gap suggests either the mortar shrank or the stone is tipped toward the platform. This pilaster is slightly out of plumb suggesting some past movement.

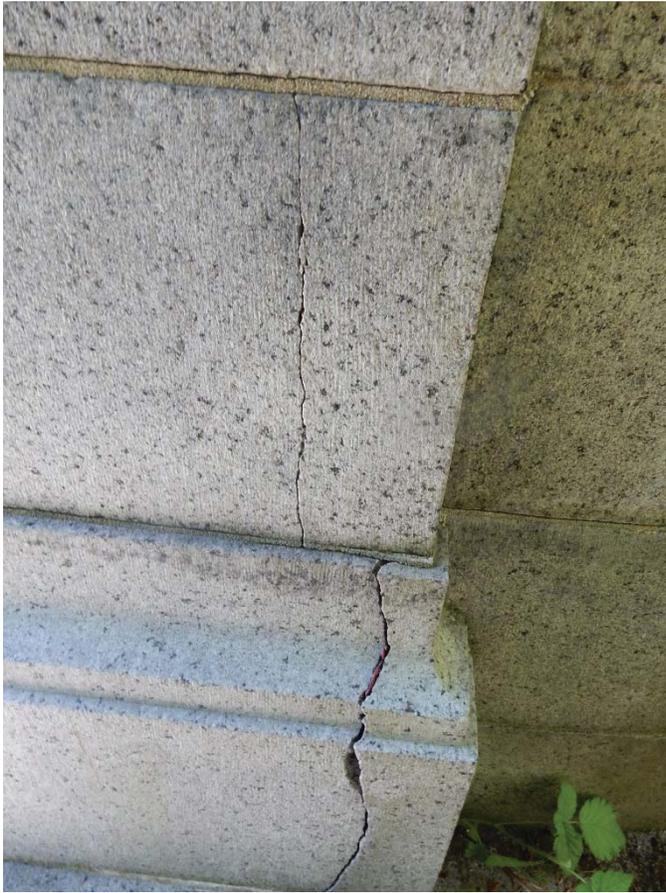
16. Crack in base stones at right most pilaster, next to Geodesic benchmark. The orientation of the crack suggests the wall is pushing the pilaster over the pilaster footing. The footing is resisting movement thereby tearing the base stone edges.

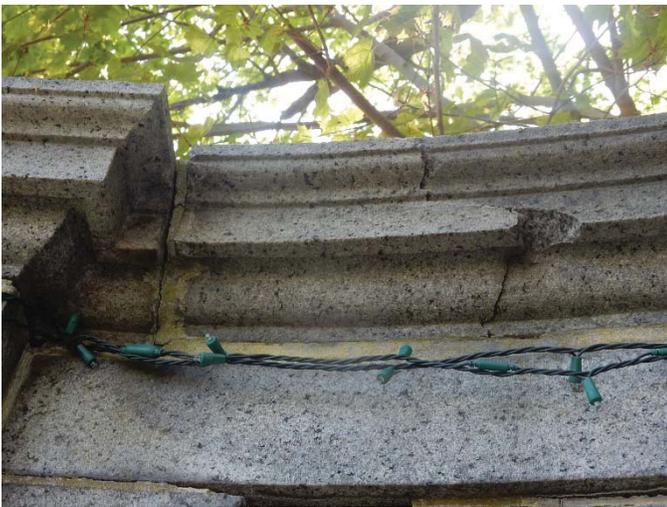
19. Cracked coping next to the pilaster at the end of the left wing. The cause is not readily apparent.

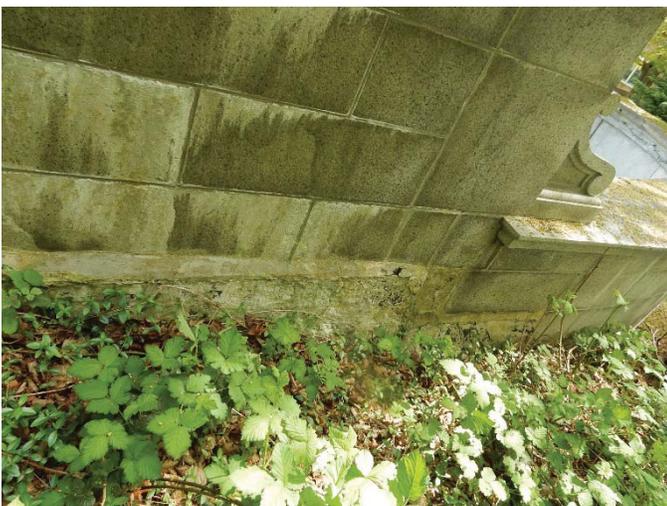
20. Salts bleeding out of the back of the center wall. Note the uncut stone facing that projects up from the backfilled portion of the wall.

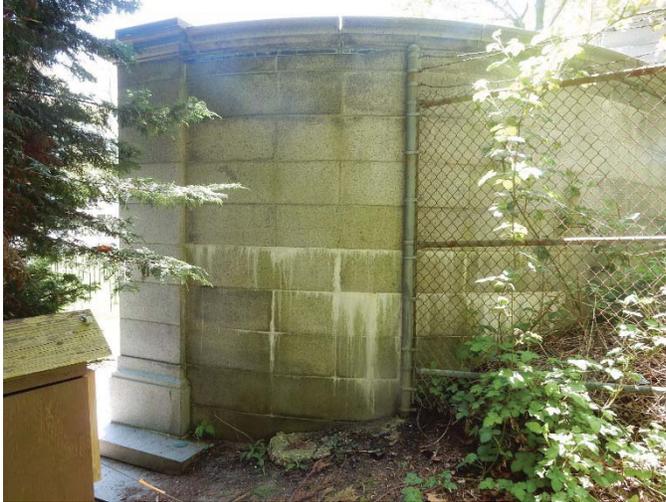
21. Back side of the right wing. Salts bleeding out of mortar joints. Note missing head joint mortar in coping. Metal flashing under coping turned down on supporting stone. On the front side, flashing is retained within bed joint.
