Standards of Practice

MONUMENT CONSERVATION COLLABORATIVE LLC, NORFOLK, CT

Cemetery: Winthrop St Cemetery, Provincetown, MA

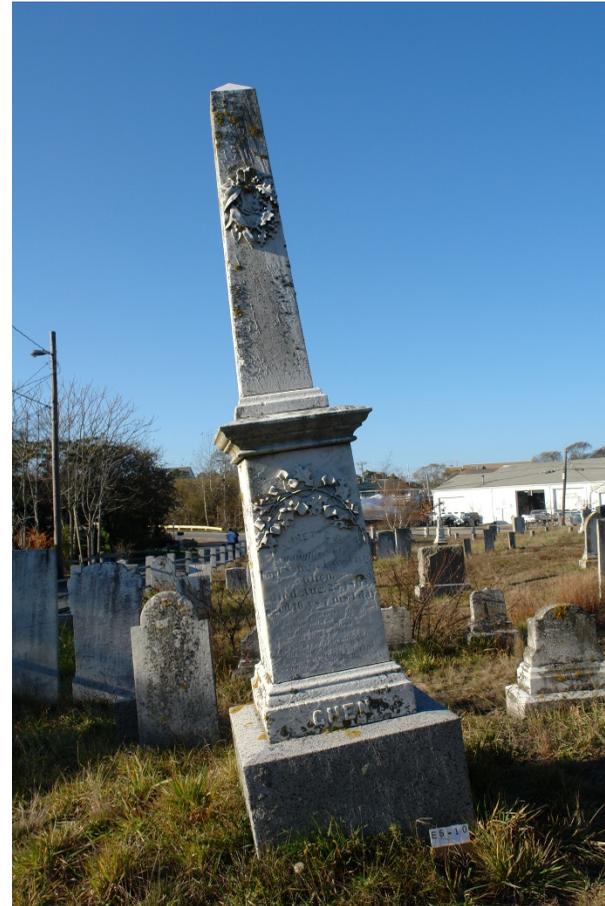
#E6-10 Ghen Monument

Older large monuments, such as the Ghen monument, are typically set on a deep bed of dry laid stones. At times these stones will shift due to ground conditions; sometimes due to burrowing animals, frost heaves, flooding, etc. causing the monument to tilt and become unstable.

At a certain angle they become hazardous to themselves, adjacent stones, and to bystanders.

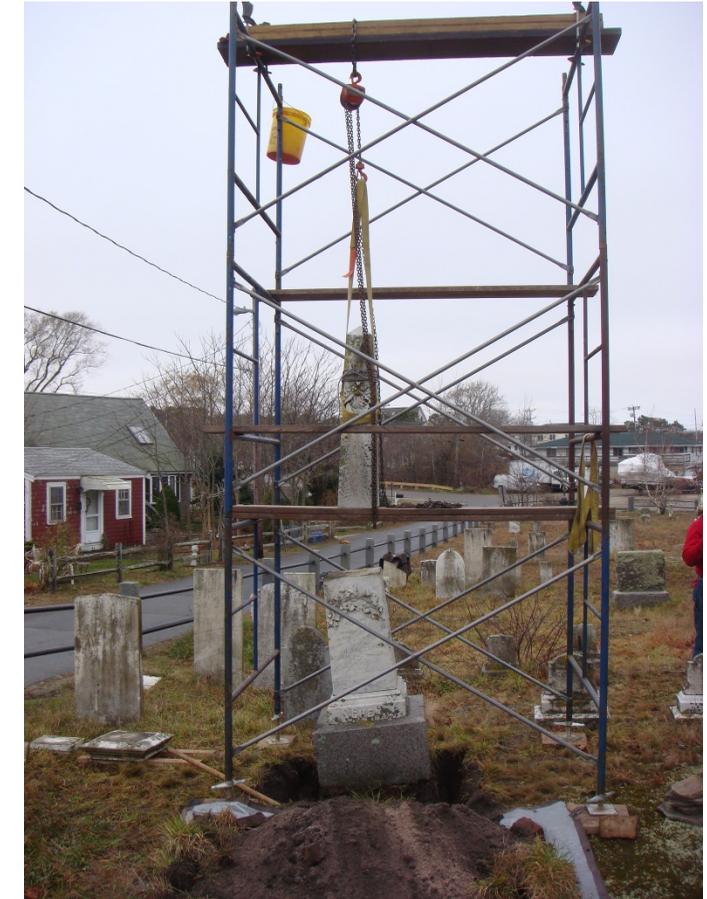
Upper element of Ghen dismantled, and granite base excavated

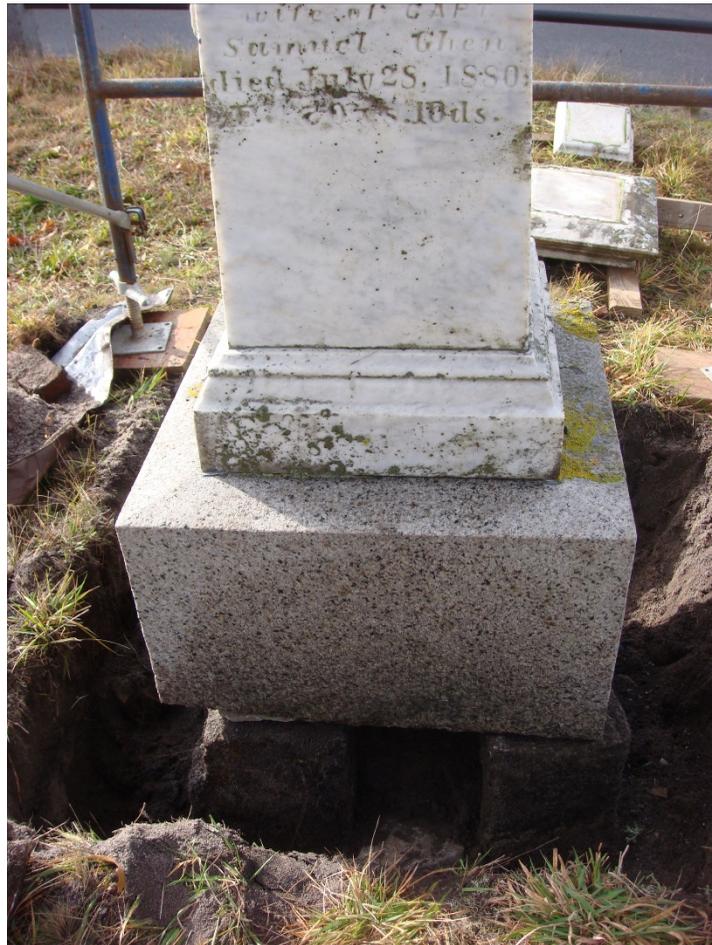
Unusual vertical granite supports under Ghen monument.

Base was raised level and stone shims were inserted on top of the granite posts

1. Elements removed from base area with mechanical assistance, inspected for soundness,
2. Area around setting base excavated exposing 4 granite posts. Base unit re-leveled onto posts with stone shims, backfill w/ sand.
3. Setting surfaces cleared of debris and any failed setting mortar removed. Setting surfaces treated with D/2 antimicrobial, scrubbed with nylon brushes and fully rinsed with water.
4. Setting bed primed with Acryl 60 diluted 1:3 with water.
5. Elements reset with a cement/lime mortar (3/2/8) with 000 sand. If necessary lead shims facilitated leveling. Excess mortar removed and joint area cleaned

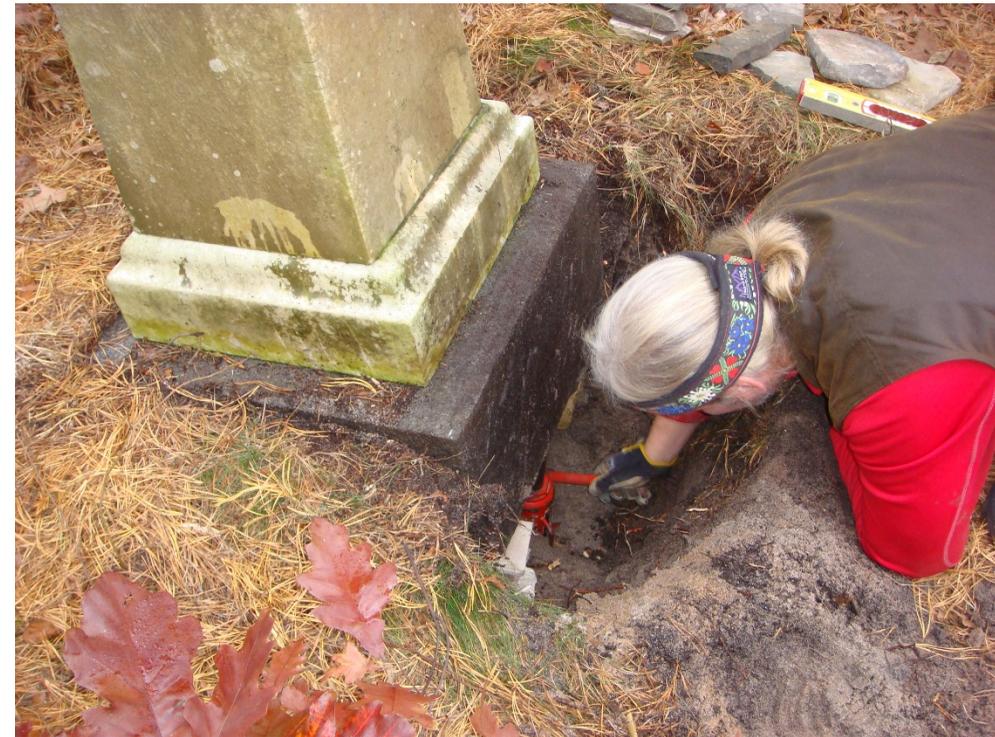
*Hydraulic jacks were used for re-leveling.
Pierce Monument*

1. Area excavated around base unit. Base unit had moved off original setting area.
2. Monument raised on one side with hydraulic jacks and loose stone rubble removed from setting area
3. Monument lowered onto setting area, and raising operation repeated on opposite side as needed.
4. Monument leveled onto setting area, shimmed with flat stones on all sides.
5. Setting surfaces primed with Acryl 1:3 and loose elements reset with a cement/lime mortar (3/2/8) with 000 sand

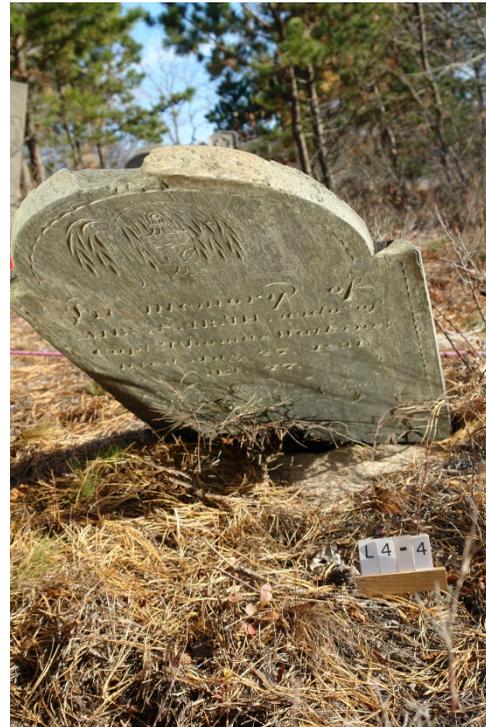
#L4.04 *Watkins, severely tilted*

Earlier gravestones are typically long panels of stone that were set directly into the ground. After determination of the correct location and orientation of the stone, soil was removed to an appropriate depth. Gravel (or broken stone) was introduced to establish a stable base. The stone was made plumb and level, and set in plane with the adjacent markers. Backfilling was done with sand and gravel, wetted and compacted. All disturbed areas were covered with existing topsoil and turf.

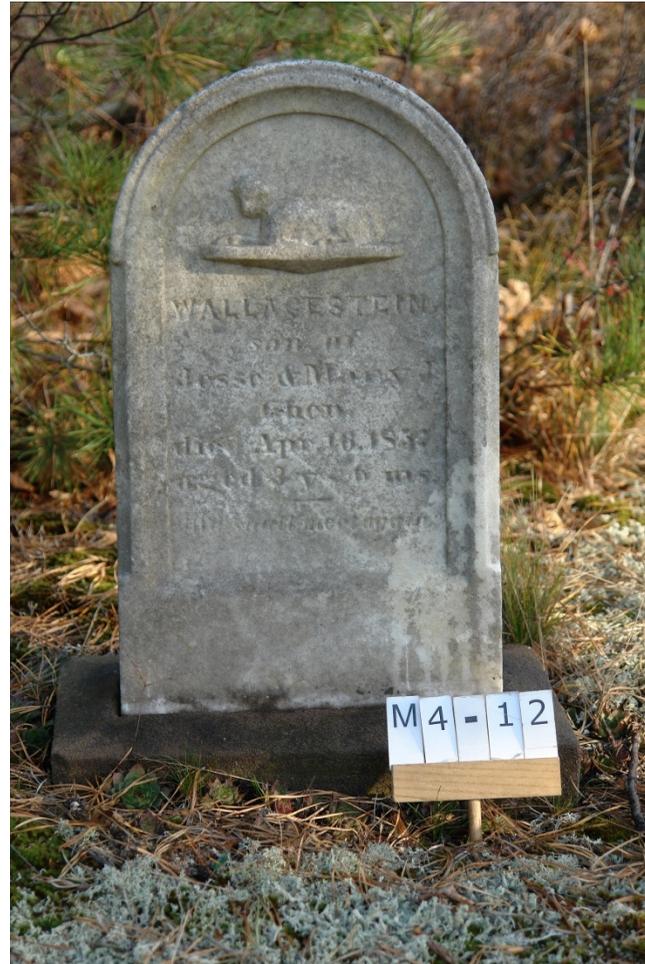
M4.12 Ghen. Reset into existing base

Gravestones that required insertion into existing bases were set with a relatively weak cement/lime-based grout (3:2:8:1) with fine aggregates (000), made fluid with a high-range water reducer. This was poured or injected into the base slot. Stones were braced for a minimum of three days to limit movement during curing of the grout.

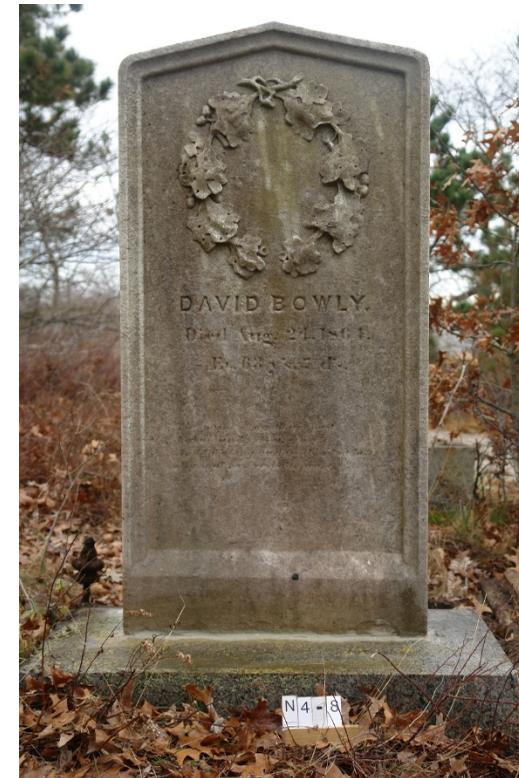
N4.08 Bowley. Reset onto existing base

TREATMENT	Date(s) of treatment
<ol style="list-style-type: none"> 1. Soundness of setting joint of marker to base inspected, if found to be unstable, marker removed from base. 2. Area excavated to an appropriate depth removing any roots or large stones. 3. Base is aligned with adjacent markers and re-set level with stone shims 4. Area around base was backfilled with tamped sand and re-graded with existing topsoil 5. Failed mortar removed from setting area and bottom of marker 6. Setting surfaces primed with Acryl 60 diluted 1:3 with water. 7. Marker reset plumb onto base with cement/lime grout (3/2/8) with 000 sand. 8. Excess grout removed and joint area cleaned. 	12/6/2011

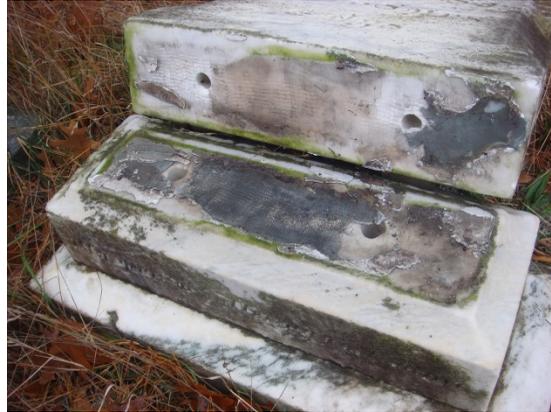
*D3.07 Burgh, above: loose pins easily removed by hand. Replaced with threaded stainless steel
Below: failed setting mortar removed from setting surfaces and areas treated with antimicrobial D/2*

TREATMENT	Date(s) of treatment
<ol style="list-style-type: none"> 1. Marker removed from base. 2. Failed mortar removed from setting area and bottom of marker 3. Existing iron pins replaced with stainless steel threaded pins 4. Setting surfaces primed with Acryl 60 diluted 1:3 with water. 5. Marker reset plumb onto base with cement/lime grout (3/2/8) with 000 sand. 6. Excess grout removed and joint area cleaned 	12/5/2011

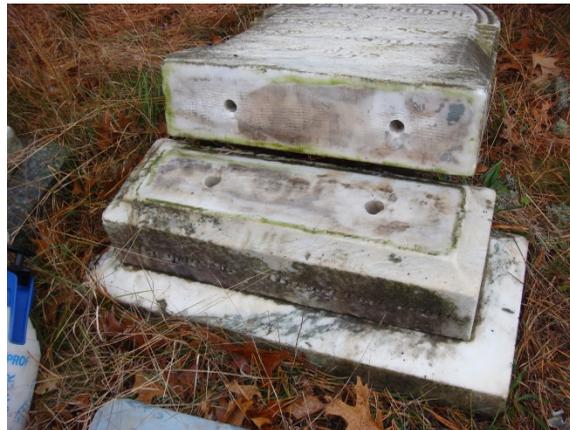
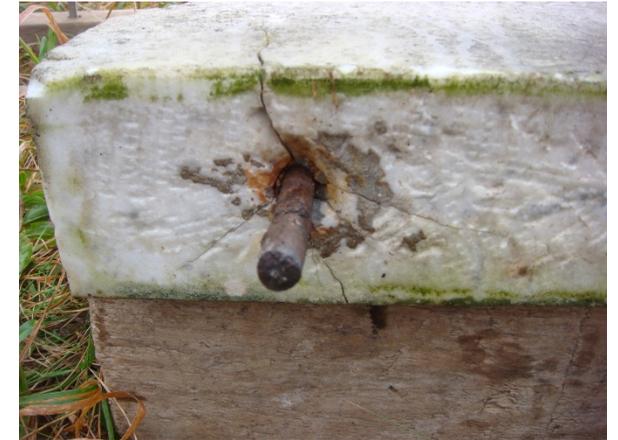
*D5.16 Roberts Above: Example of cracking cause by rusted pin.
Below: Iron pins removed with core drill, replaced with threaded stainless steel.*

TREATMENT	Date(s) of treatment
<ol style="list-style-type: none"> 1. Marker removed from base. 2. Failed mortar removed from setting area and bottom of marker 3. Existing iron pins removed, replaced with stainless steel threaded pins 4. Setting surfaces primed with Acryl 60 diluted 1:3 with water. 5. Marker reset plumb onto base with cement/lime grout (3/2/8) with 000 sand. 6. Excess grout removed and joint area cleaned 	12/5/2011

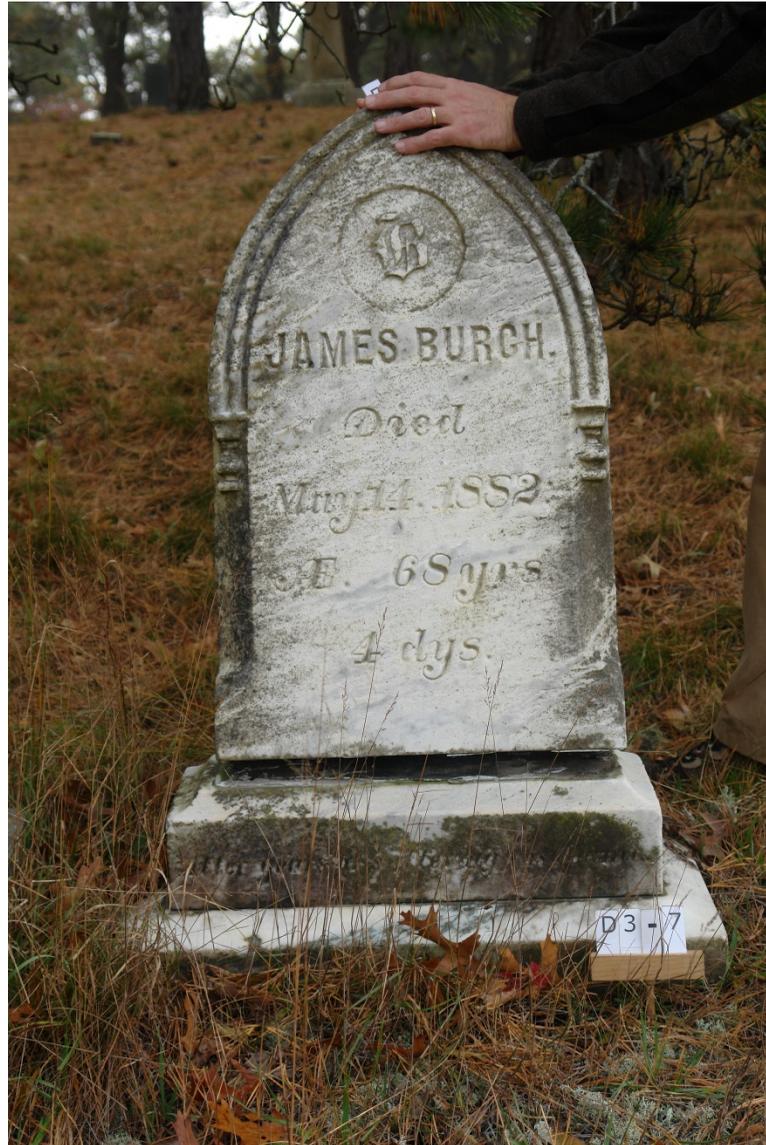
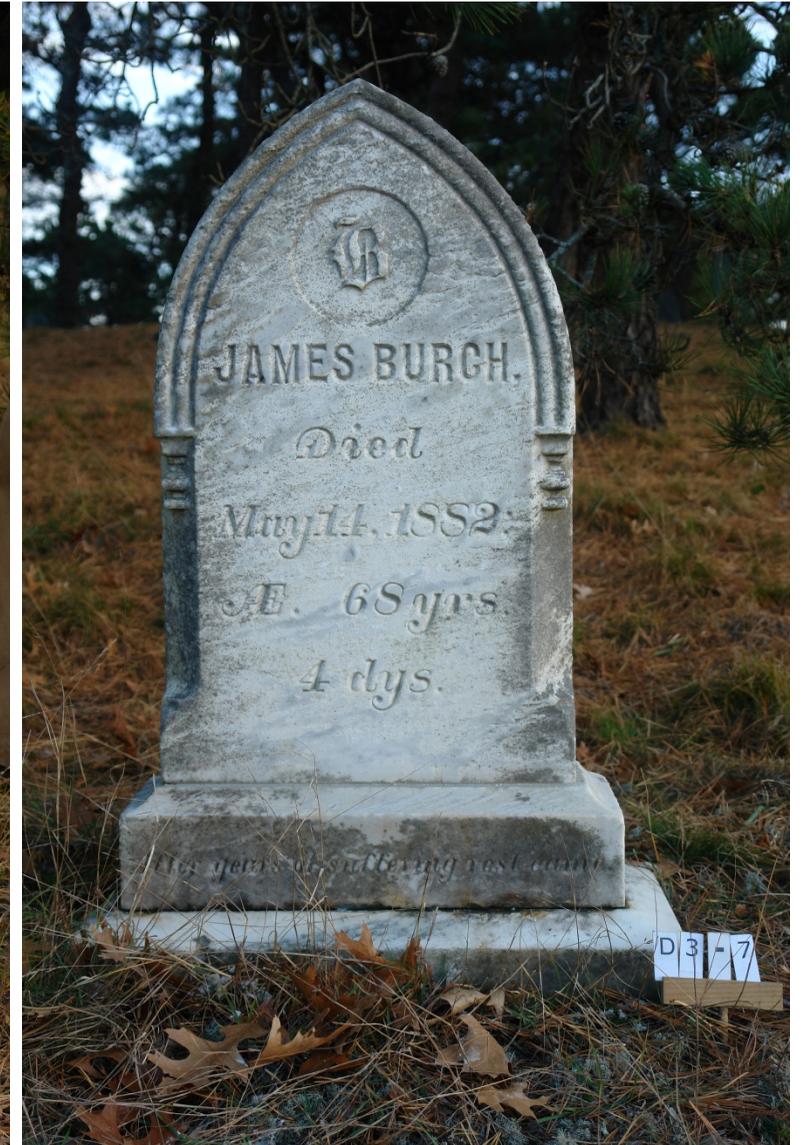
Marker# **D3.07**

EXISTING CONDITIONS	CONSERVATION STRATEGY
Loose on base	Reset headstone to base

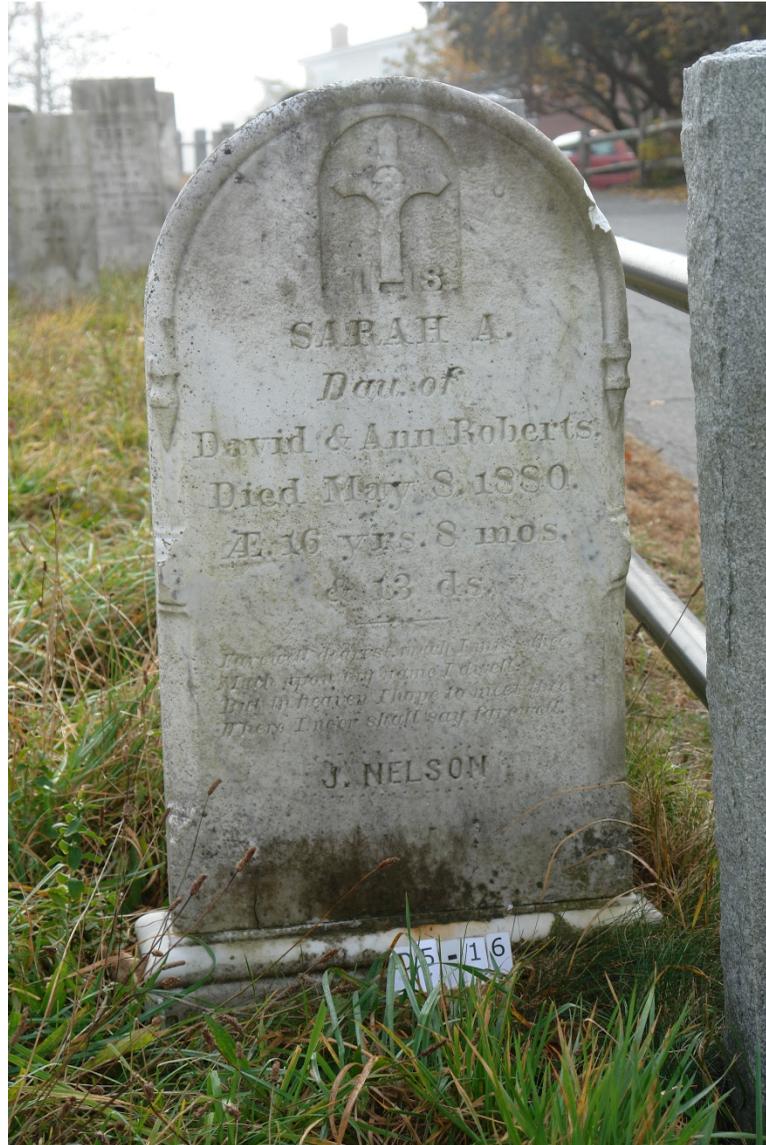
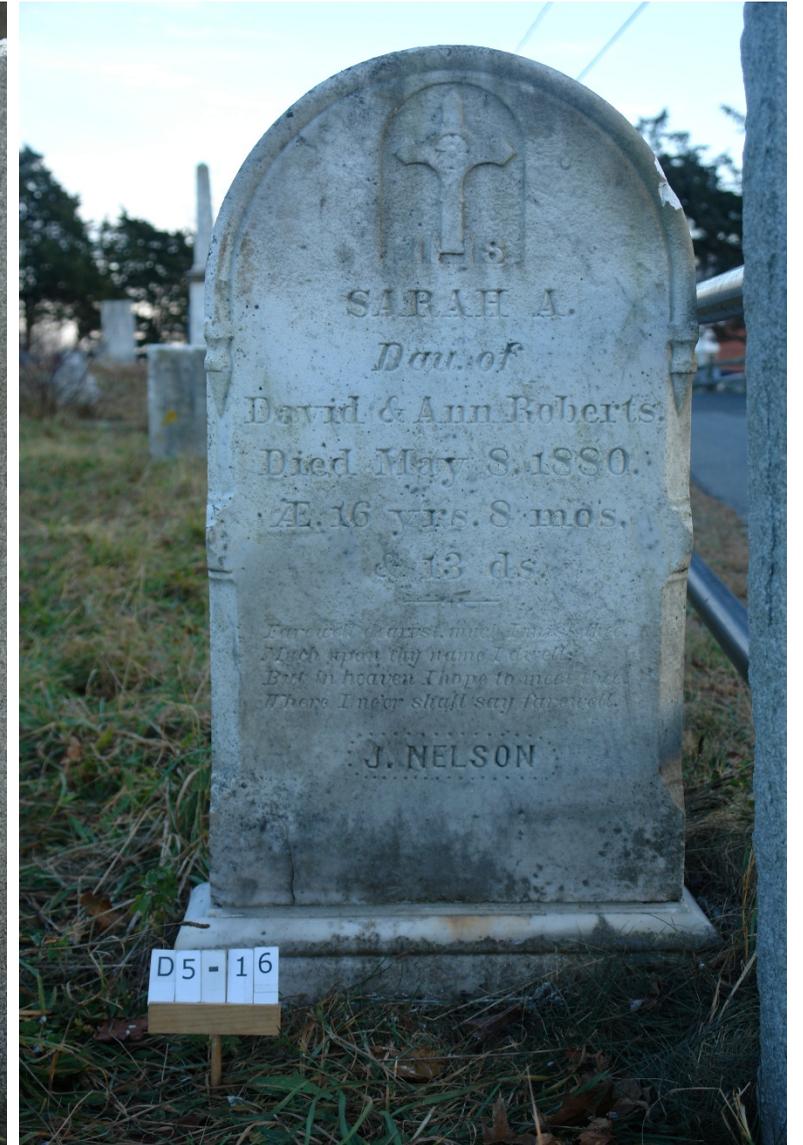
Marker# **D5.16**

EXISTING CONDITIONS	CONSERVATION STRATEGY
Loose on base	Reset headstone to base

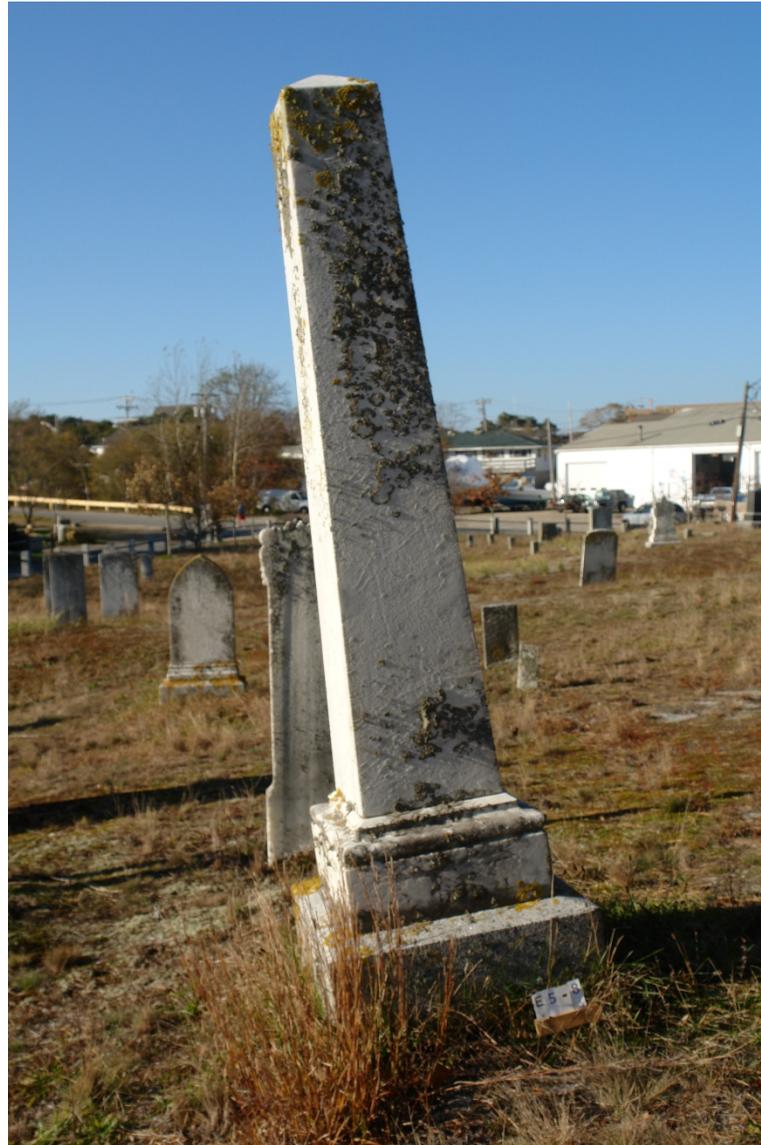
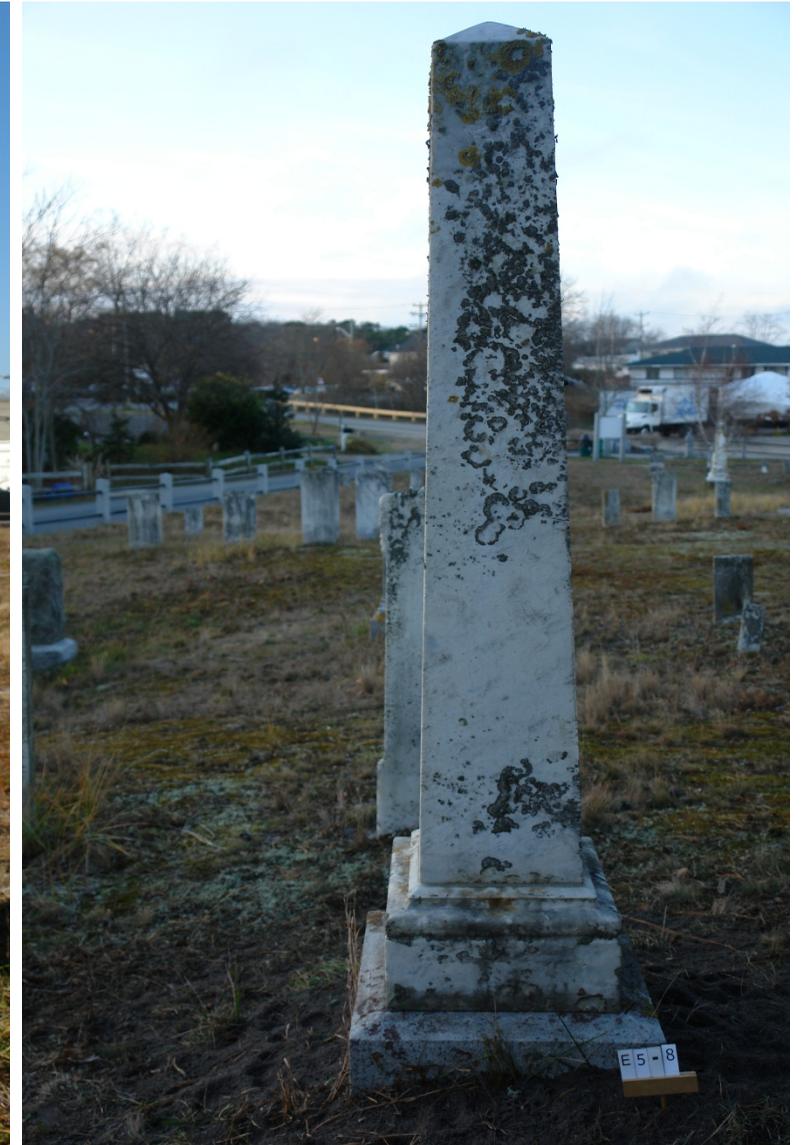
Marker# **E5.08**

Base unit not level Level base unit

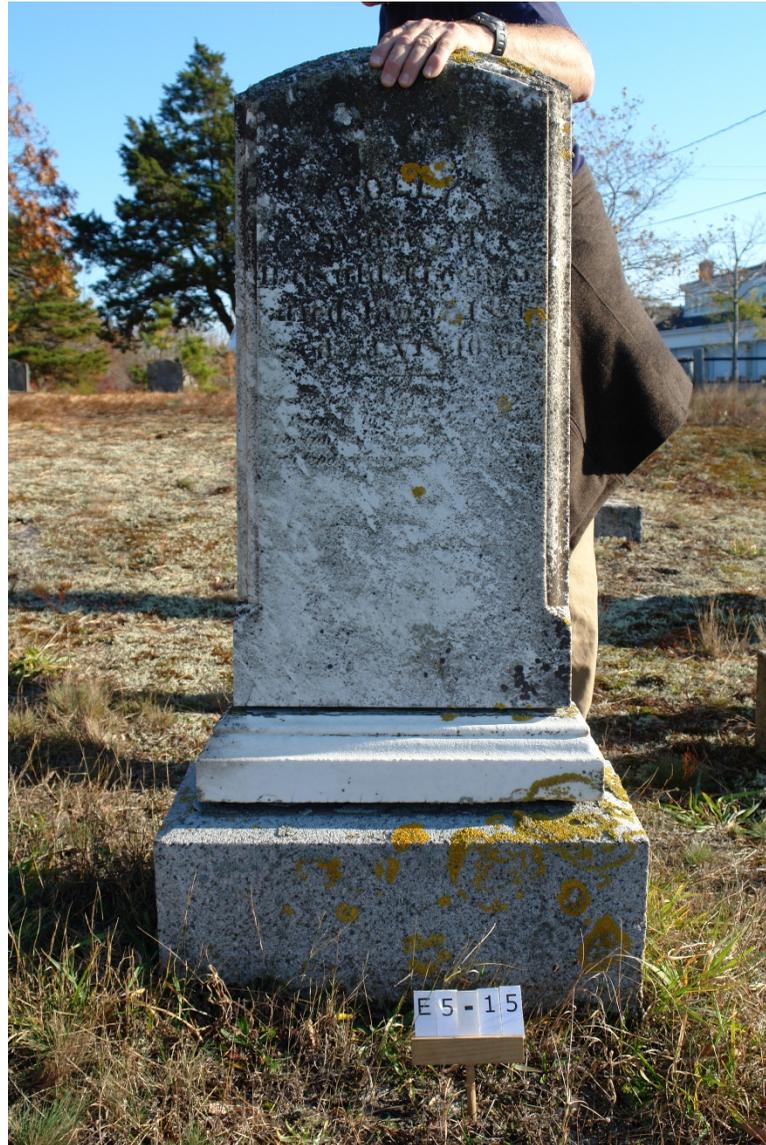
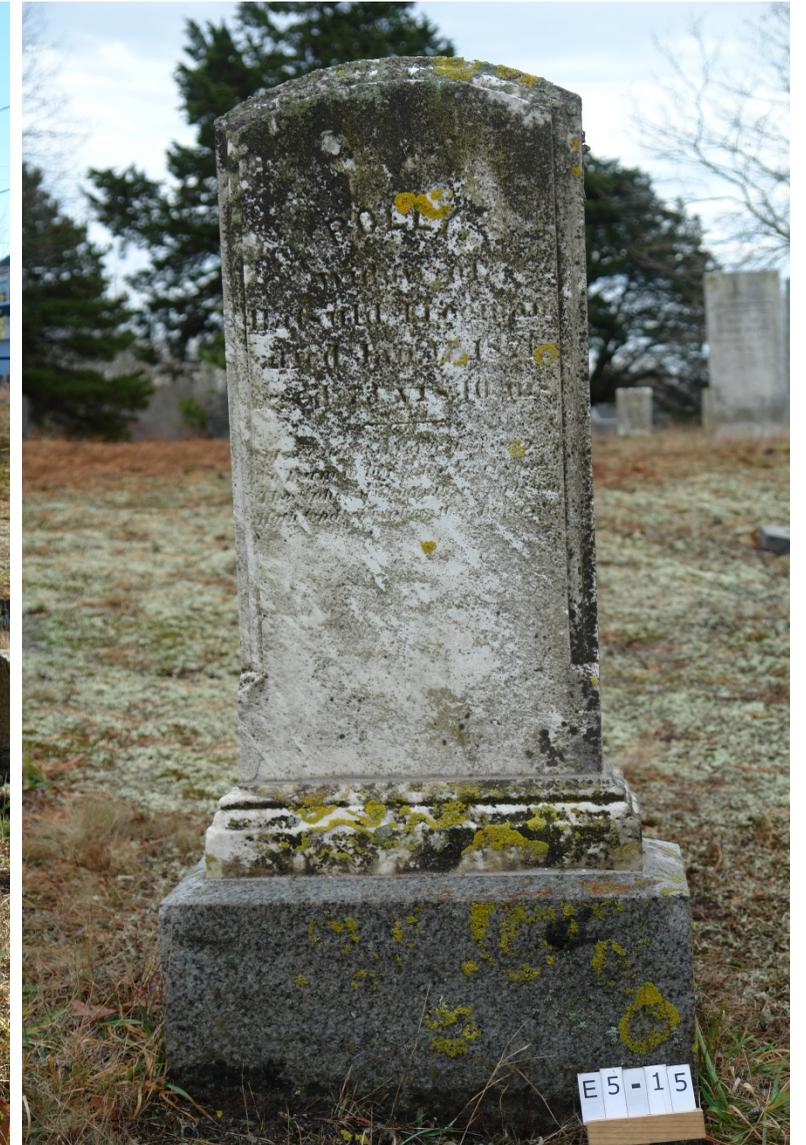
Marker# **E5.15**

Loose on base

1. Marker and plinth base removed from setting base.
2. Failed mortar removed from setting area and bottom of marker
3. When required, any existing pins were inspected, and if necessary, replaced with stainless steel threaded pins
4. Setting surfaces primed with Acryl 60 diluted 1:3 with water.
5. Marker reset plumb onto base with cement/lime grout (3/2/8) with 000 sand.
6. Excess grout removed and joint area cleaned

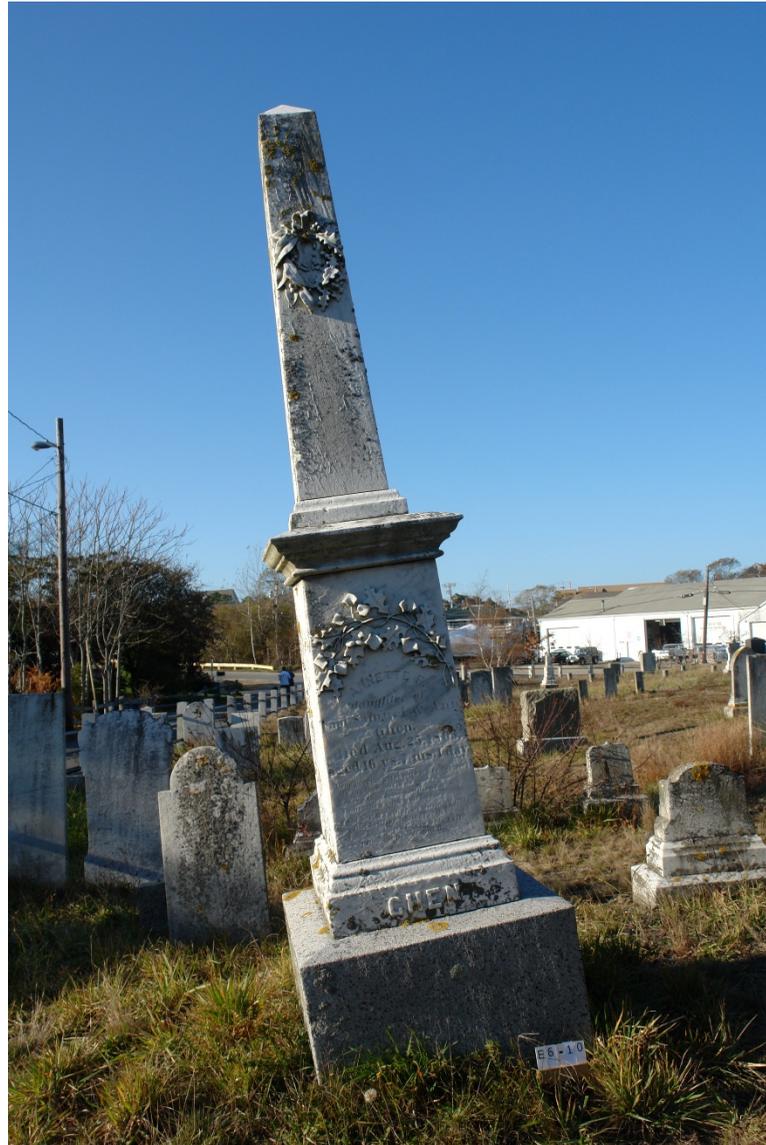
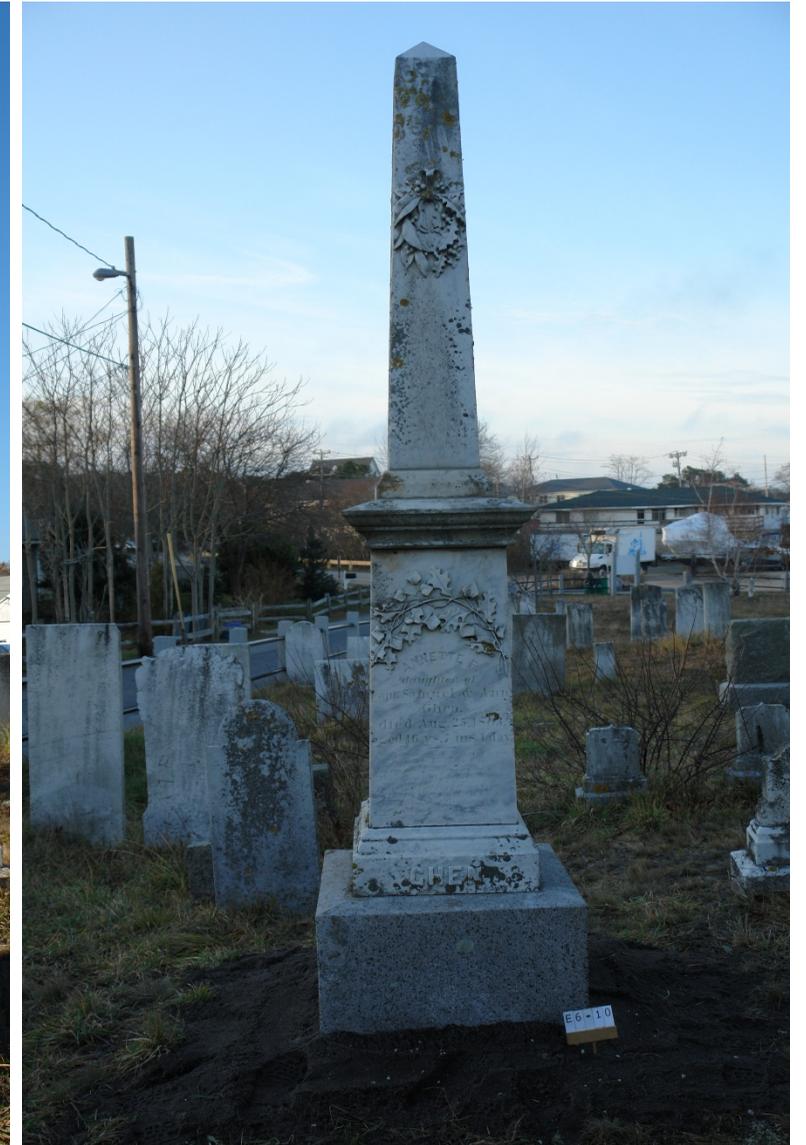
Marker# **E6.10**

Tilted base **Reset base unit level**
Elements not set to base units **Reset elements**

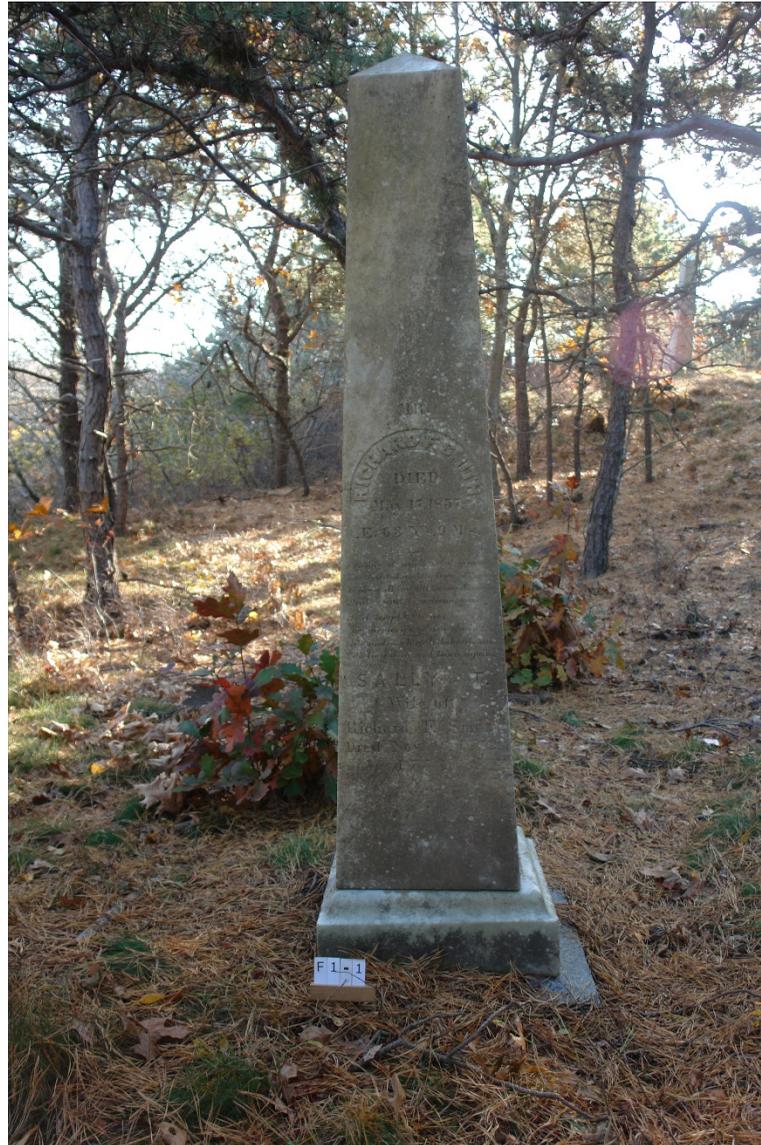
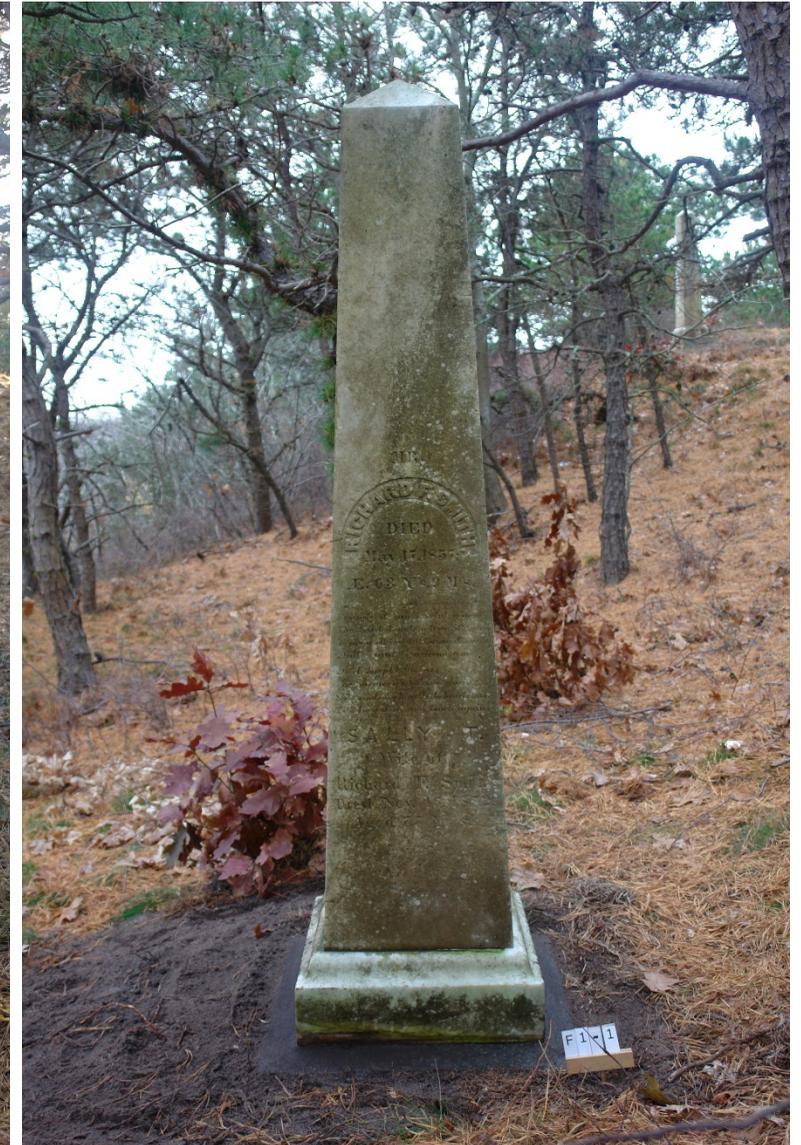
Marker# **F1.01**

EXISTING CONDITIONS	CONSERVATION STRATEGY
Base unit not level	Level base unit

TREATMENT	Date(s) of treatment
<ol style="list-style-type: none"> 1. Soil removed around base unit and base jacked up to level. 2. Existing foundation stones exposed and built up to support base unit. 3. Base re-set plumb at appropriate height and level, aligned with adjacent markers 4. Area beneath and around base backfilled with tamped sand and gravel 5. Disturbed areas re-graded with existing topsoil. 	12/6/2011

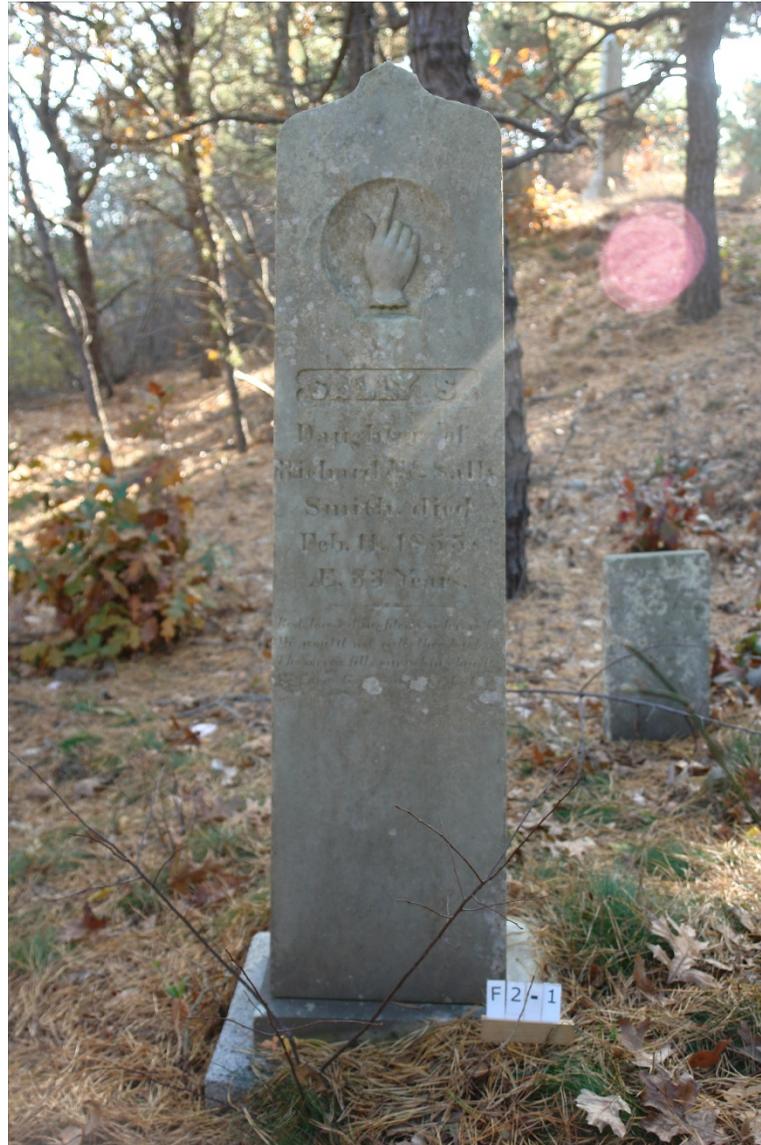
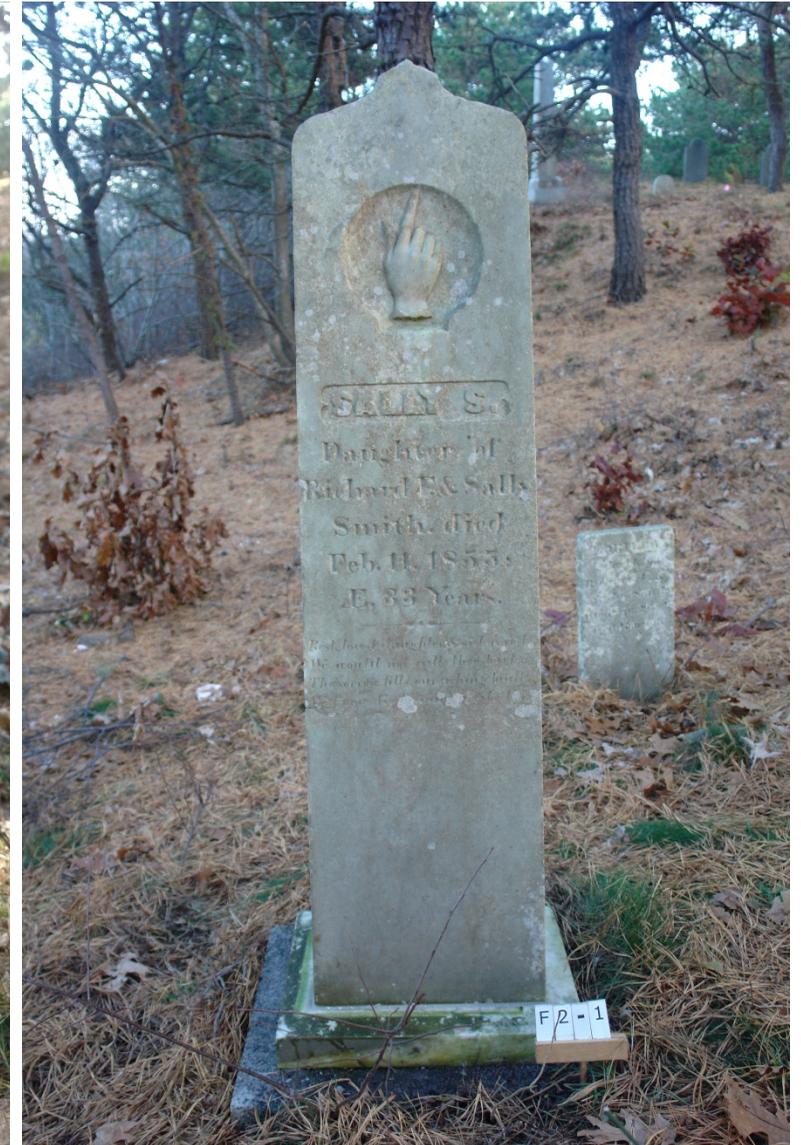
Marker# **F2.01**

Loose on base

1. Marker removed from base.
2. Failed mortar removed from setting area and bottom of marker
3. When required, any existing pins were inspected, and if necessary, replaced with stainless steel threaded pins
4. Setting surfaces primed with Acryl 60 diluted 1:3 with water.
5. Marker reset plumb onto base with cement/lime grout (3/2/8) with 000 sand.
6. Excess grout removed and joint area cleaned

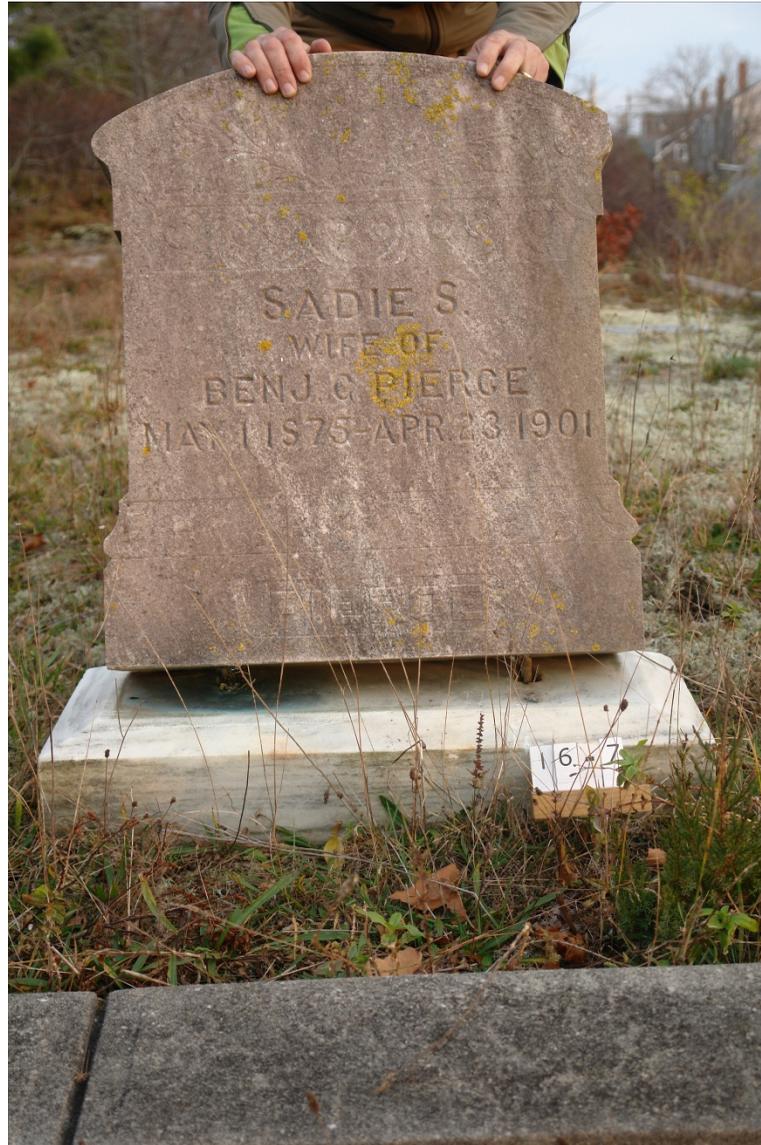
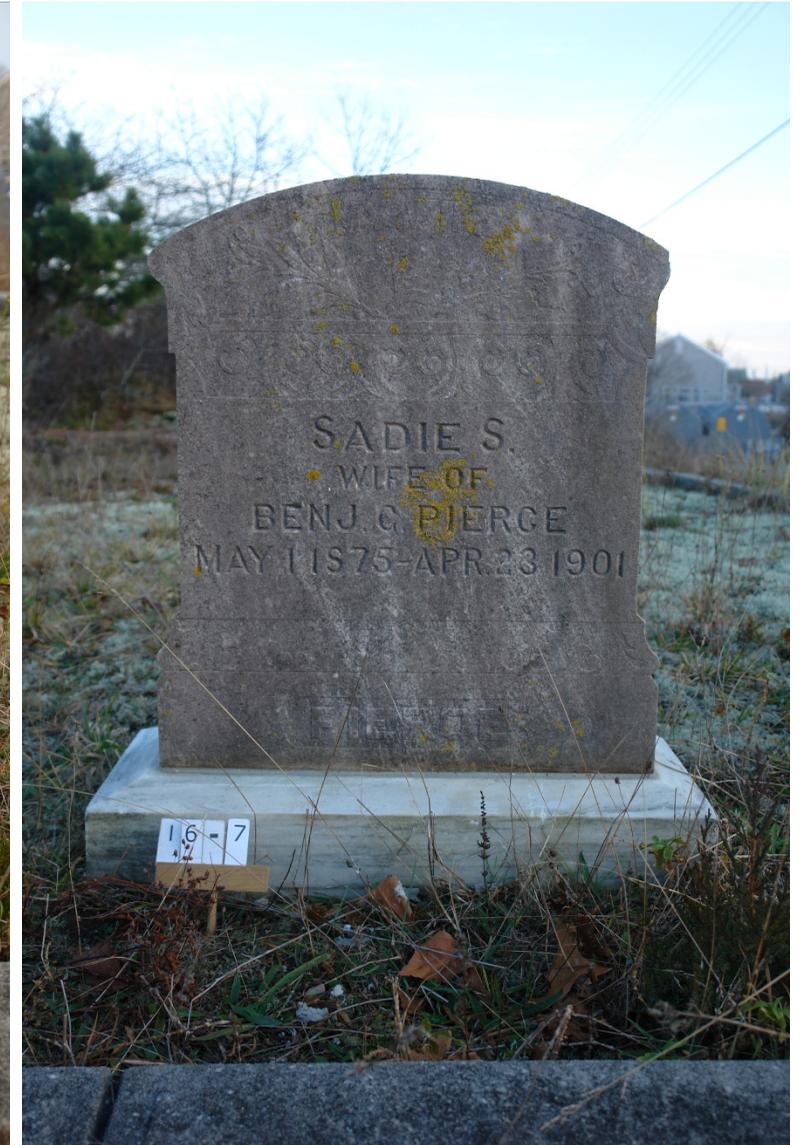
**Loose on base
Check base unit for level**

1. Marker removed from base.
2. Failed mortar removed from setting area and bottom of marker
3. When required, any existing pins were inspected, and if necessary, replaced with stainless steel threaded pins
4. Setting surfaces primed with Acryl 60 diluted 1:3 with water.
5. Marker reset plumb onto base with cement/lime grout (3/2/8) with 000 sand.
6. Excess grout removed and joint area cleaned

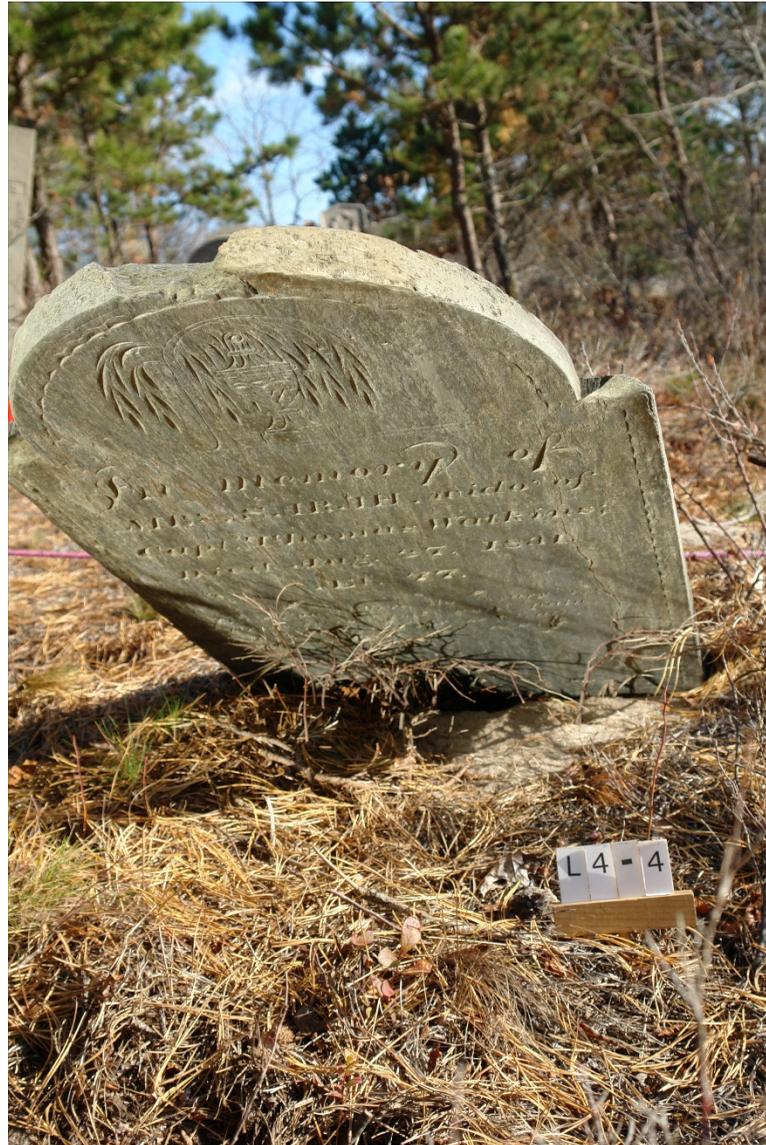
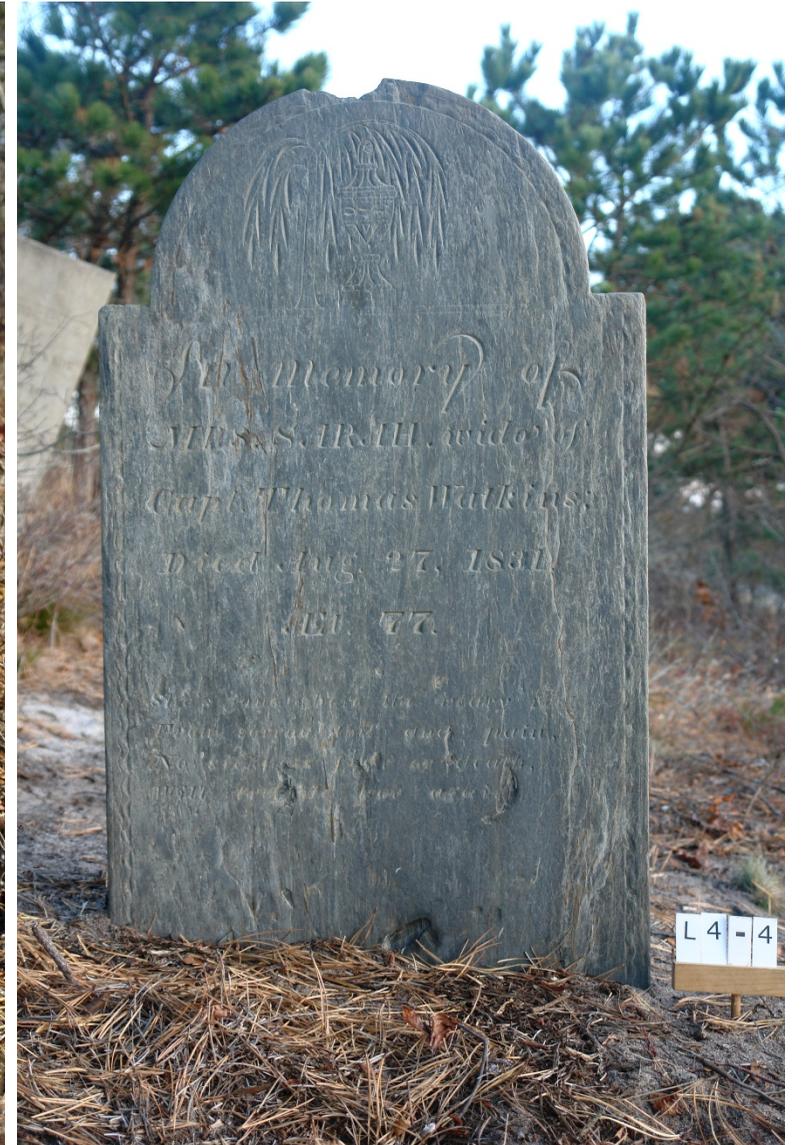
Marker# **L4.04**

EXISTING CONDITIONS	CONSERVATION STRATEGY
Extremely tilted large headstone	Reset headstone plumb
