Standards of Practice

MONUMENT CONSERVATION COLLABORATIVE LLC, NORFOLK, CT

Cemetery: Winthrop St Cemetery, Provincetown, MA

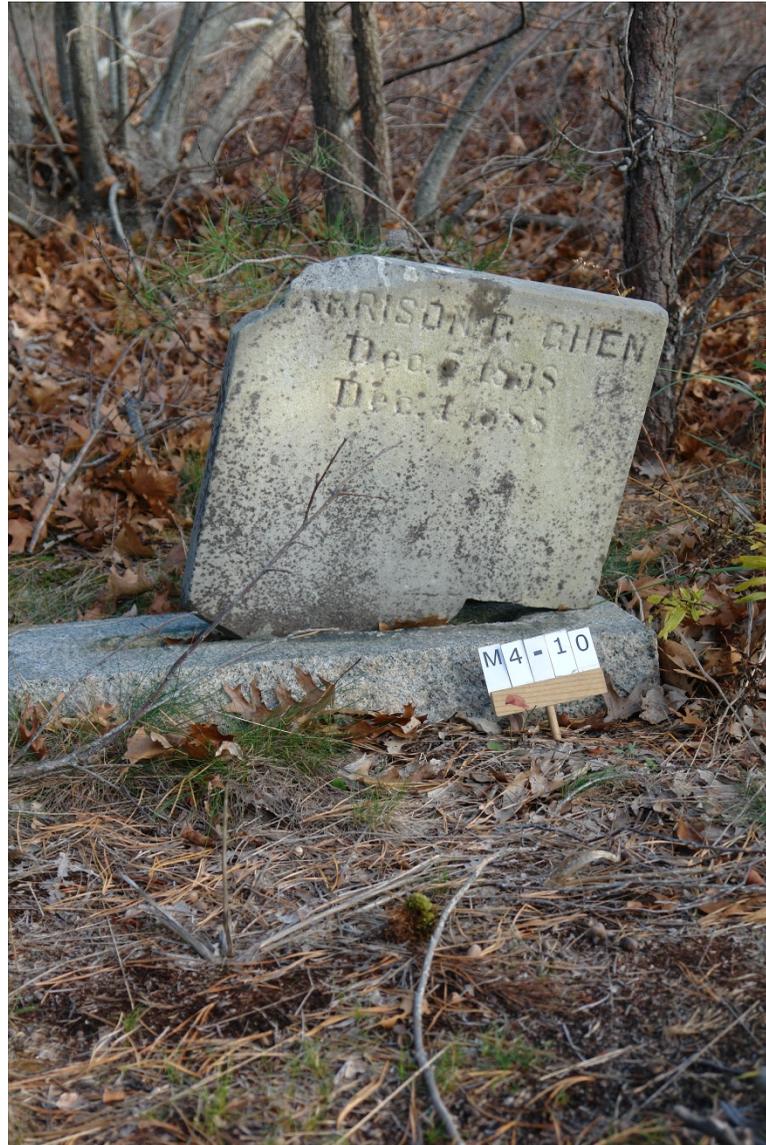
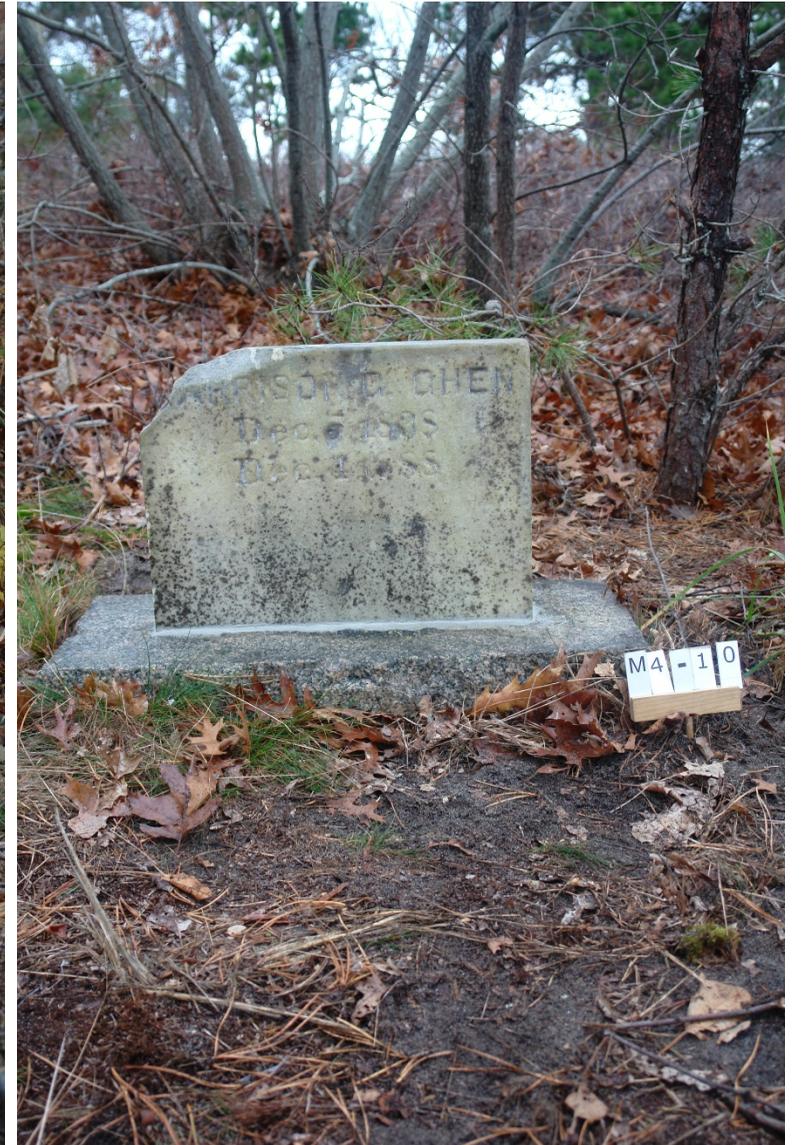
Marker# **M4.10**

EXISTING CONDITIONS	CONSERVATION STRATEGY
Fragmented marker loose in base slot	Level base unit Reset headstone to base

TREATMENT	Date(s) of treatment
<ol style="list-style-type: none"> Debris removed from setting slot. Marker inspected and found to be sound. The lower setting edge was re-squared by power grinder with minimal loss. Marker reset plumb and level into setting slot with a cement/lime grout (3/2/8) with 000 sand made fluid with a super plasticizer. Excess grout removed and joint area cleaned. 	12/6/2011

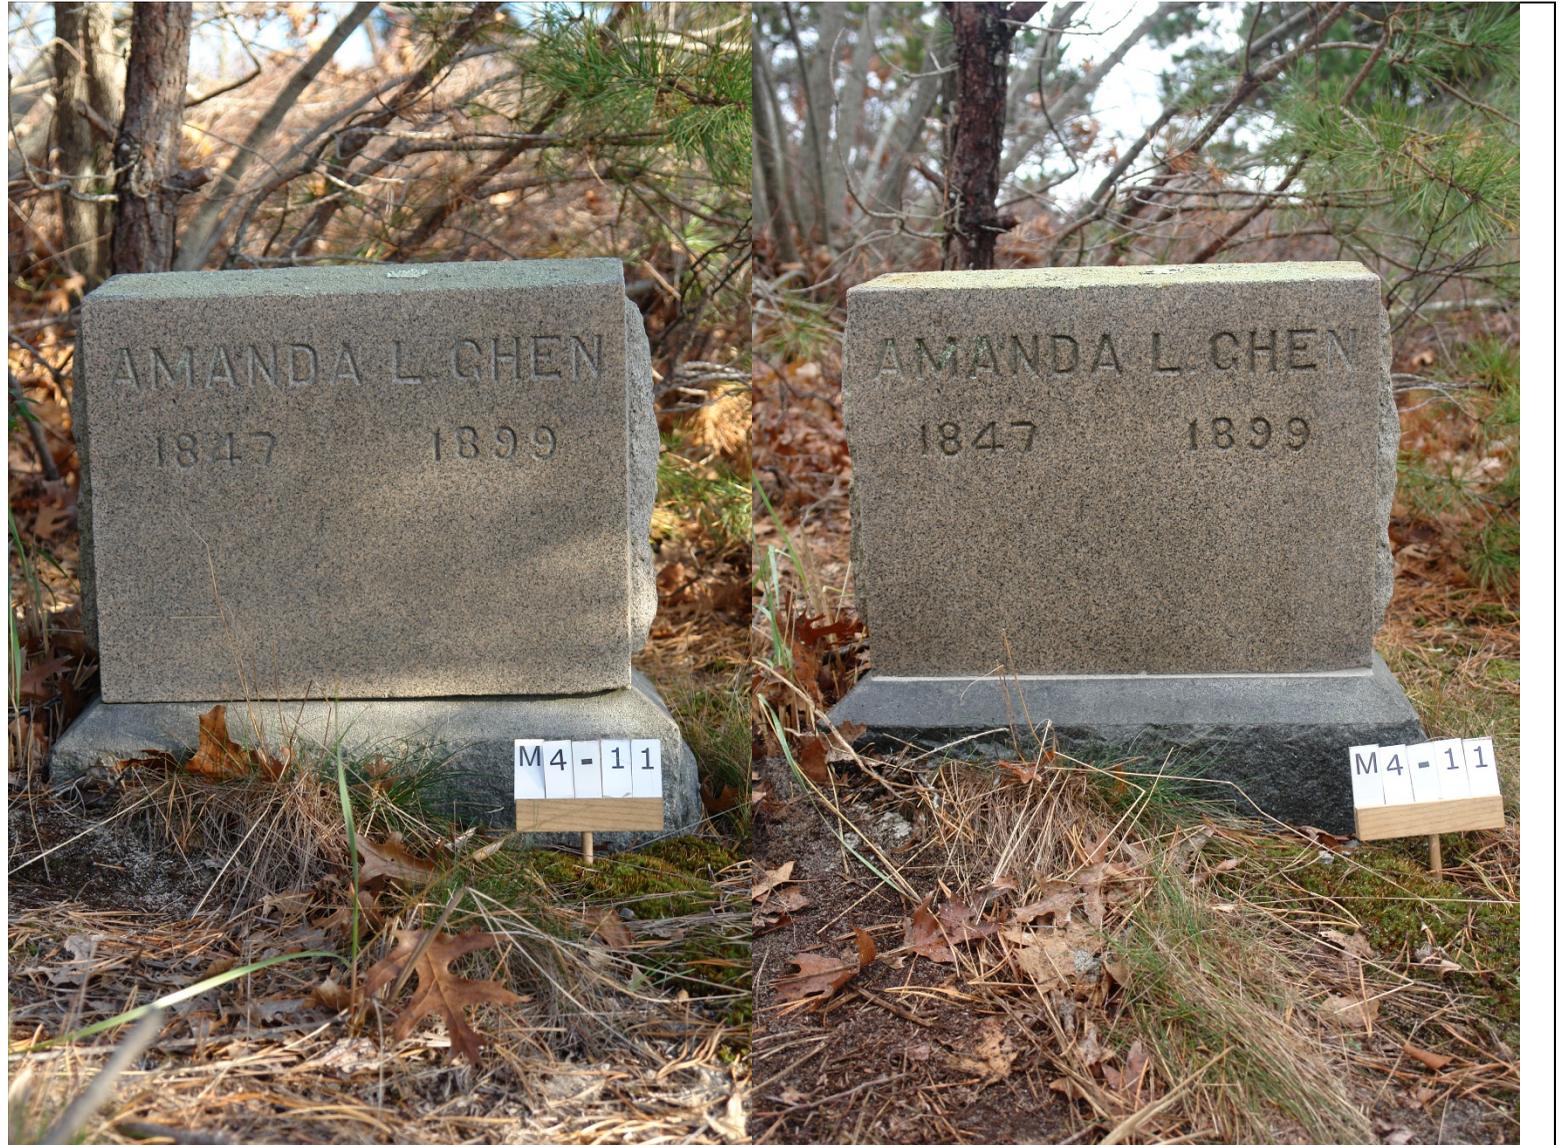
Marker# **M4.11**

Loose on base

1. Marker removed from base.
2. Failed mortar removed from setting area and bottom of marker
3. When required, any existing pins were inspected, and if necessary, replaced with stainless steel threaded pins
4. Setting surfaces primed with Acryl 60 diluted 1:3 with water.
5. Marker reset plumb onto base with cement/lime grout (3/2/8) with 000 sand.
6. Excess grout removed and joint area cleaned

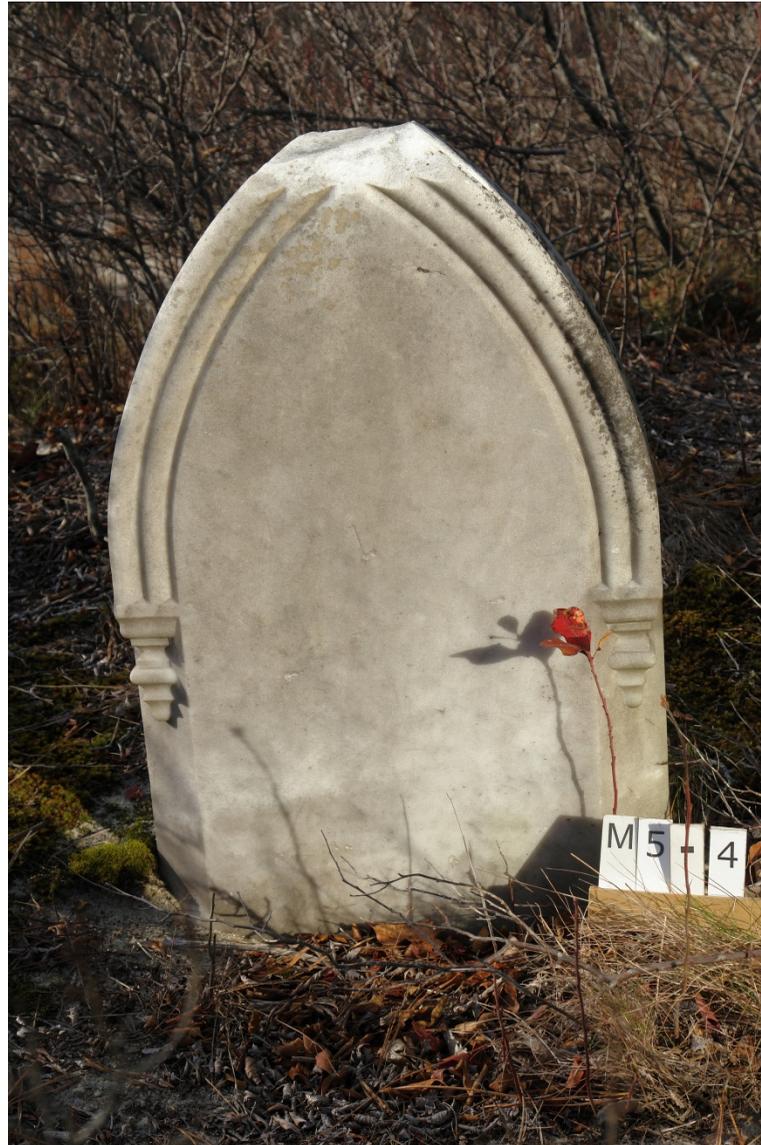
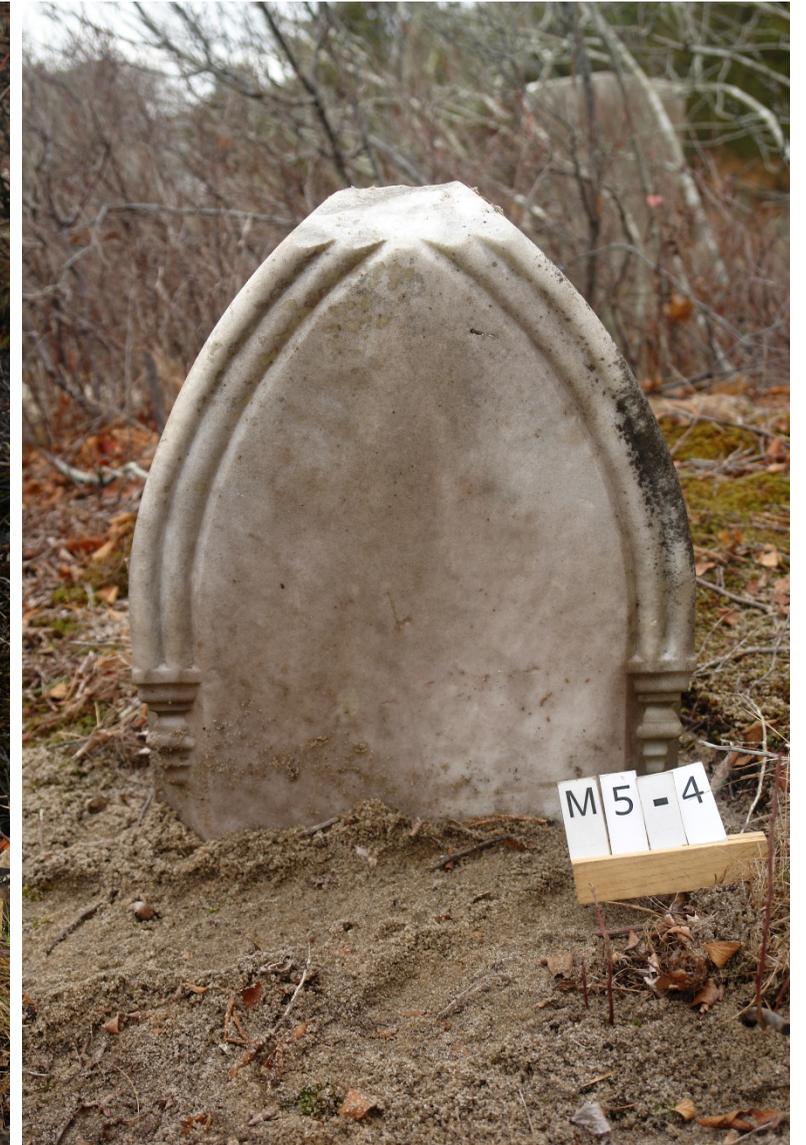
Loose on base Base unit not level	Level base unit Reset headstone to base
--------------------------------------	--

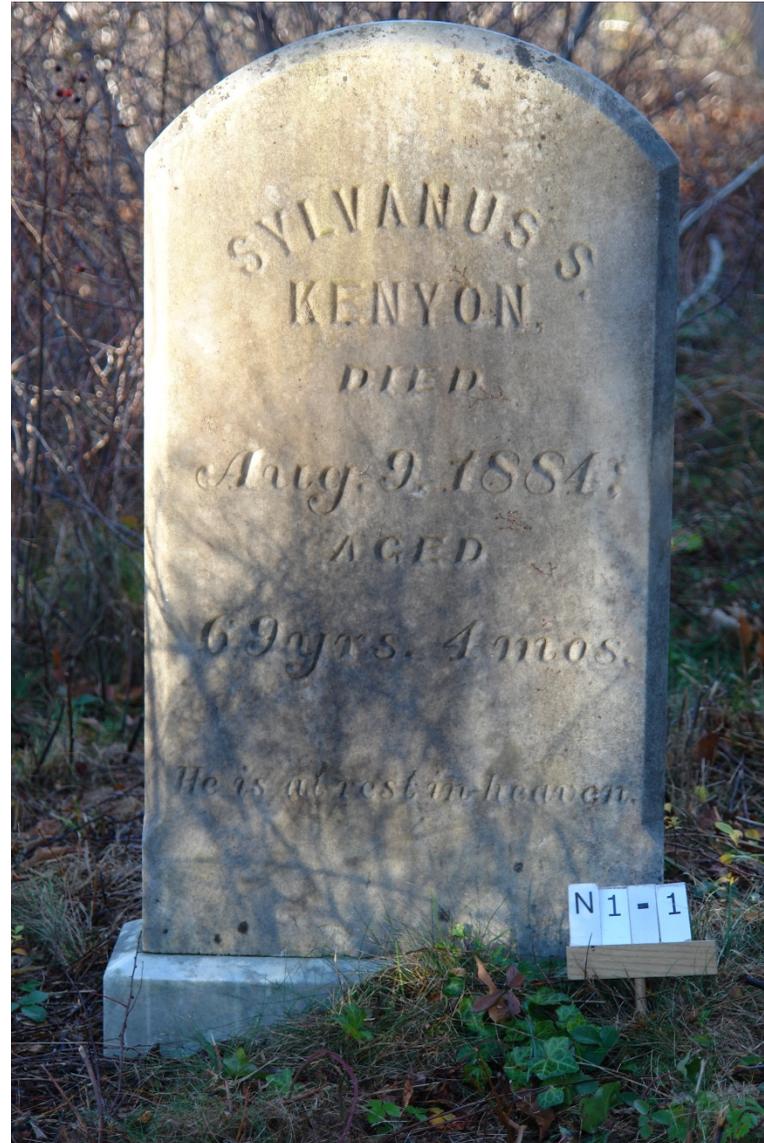
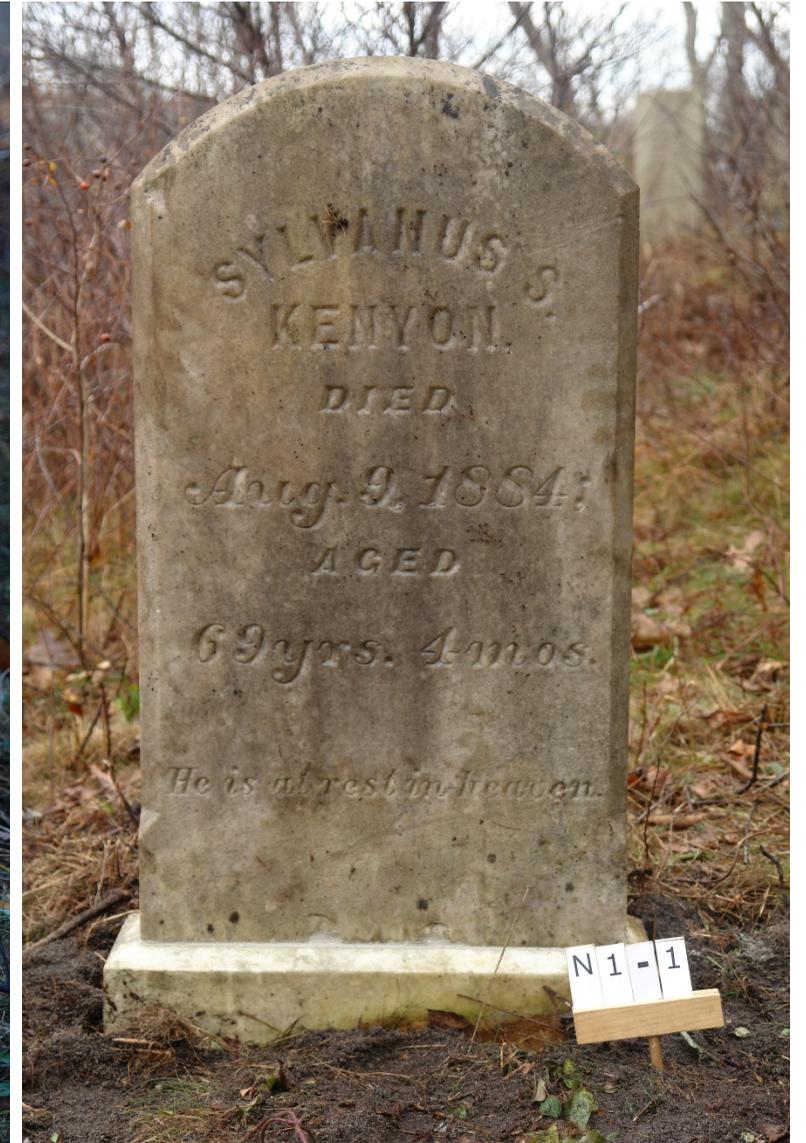
Marker# **N1.01**

Loose on base Reset headstone to base

1. Marker removed from base.
2. Failed mortar removed from setting area and bottom of marker
3. When required, any existing pins were inspected, and if necessary, replaced with stainless steel threaded pins
4. Setting surfaces primed with Acryl 60 diluted 1:3 with water.
5. Marker reset plumb onto base with cement/lime grout (3/2/8) with 000 sand.
6. Excess grout removed and joint area cleaned

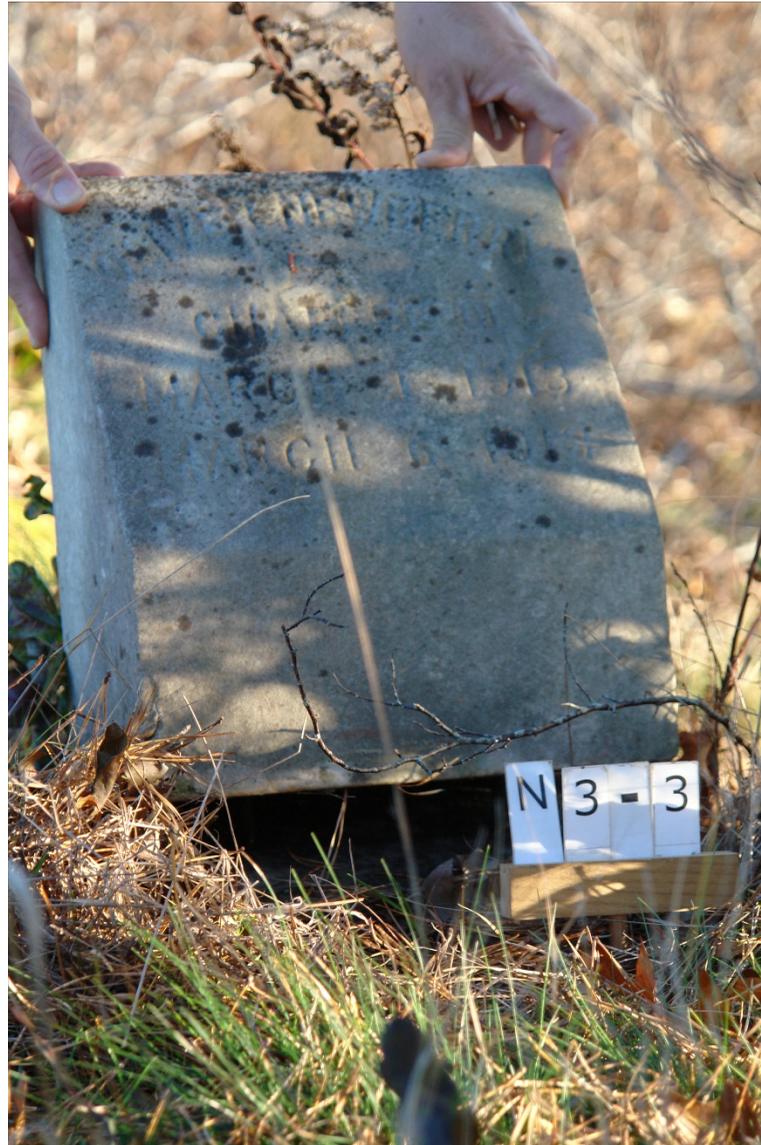
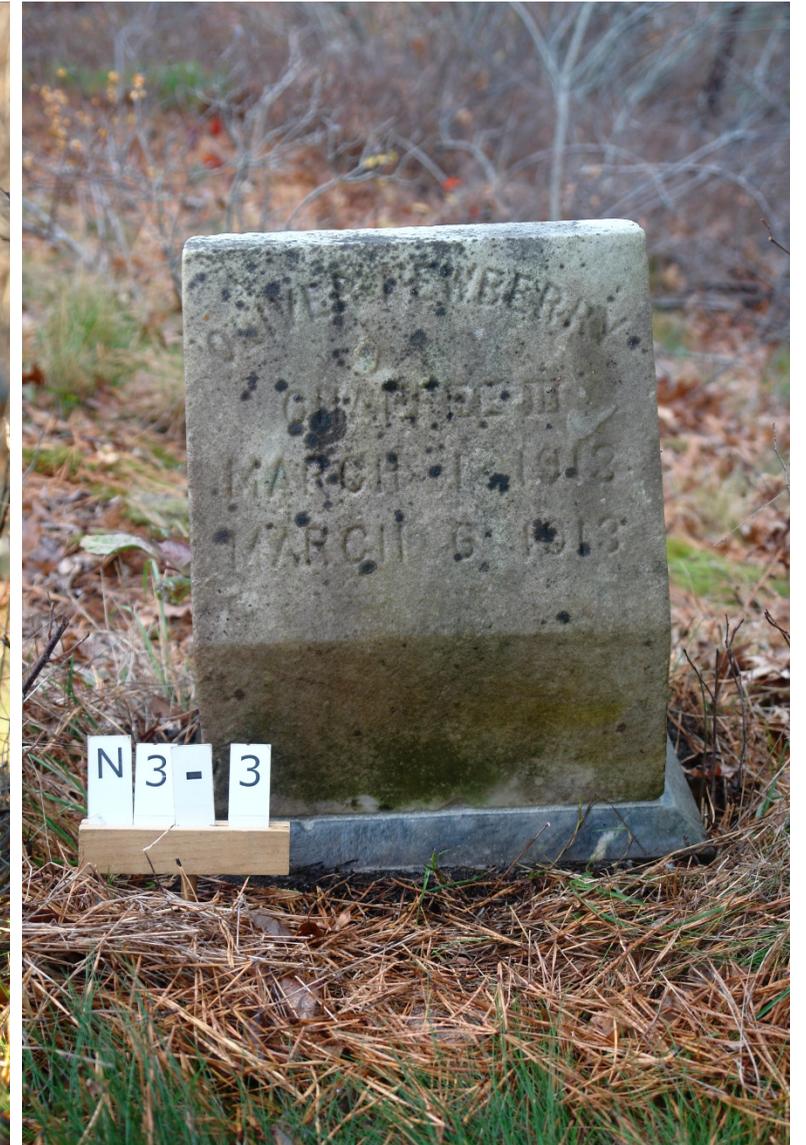
Marker# **N3.03**

Die loose from base Reset die to base

1. Marker removed from base.
2. Failed mortar removed from setting area and bottom of marker
3. When required, any existing pins were inspected, and if necessary, replaced with stainless steel threaded pins
4. Setting surfaces primed with Acryl 60 diluted 1:3 with water.
5. Marker reset plumb onto base with cement/lime grout (3/2/8) with 000 sand.
6. Excess grout removed and joint area cleaned

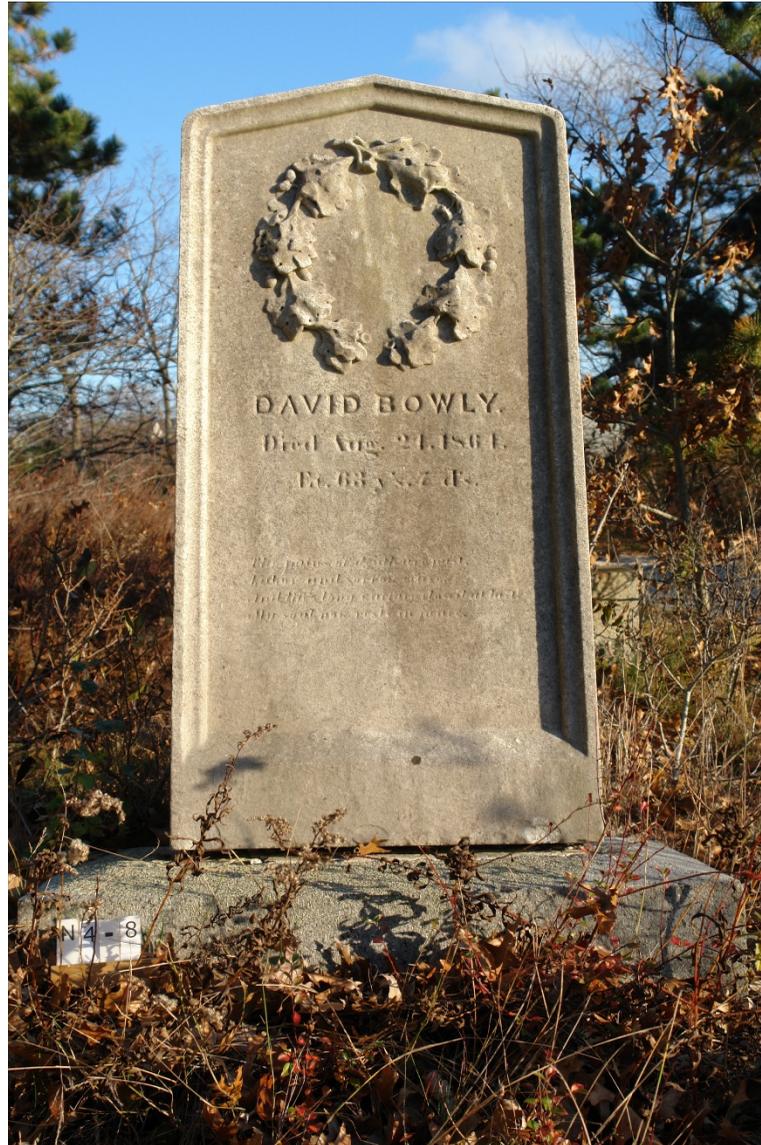
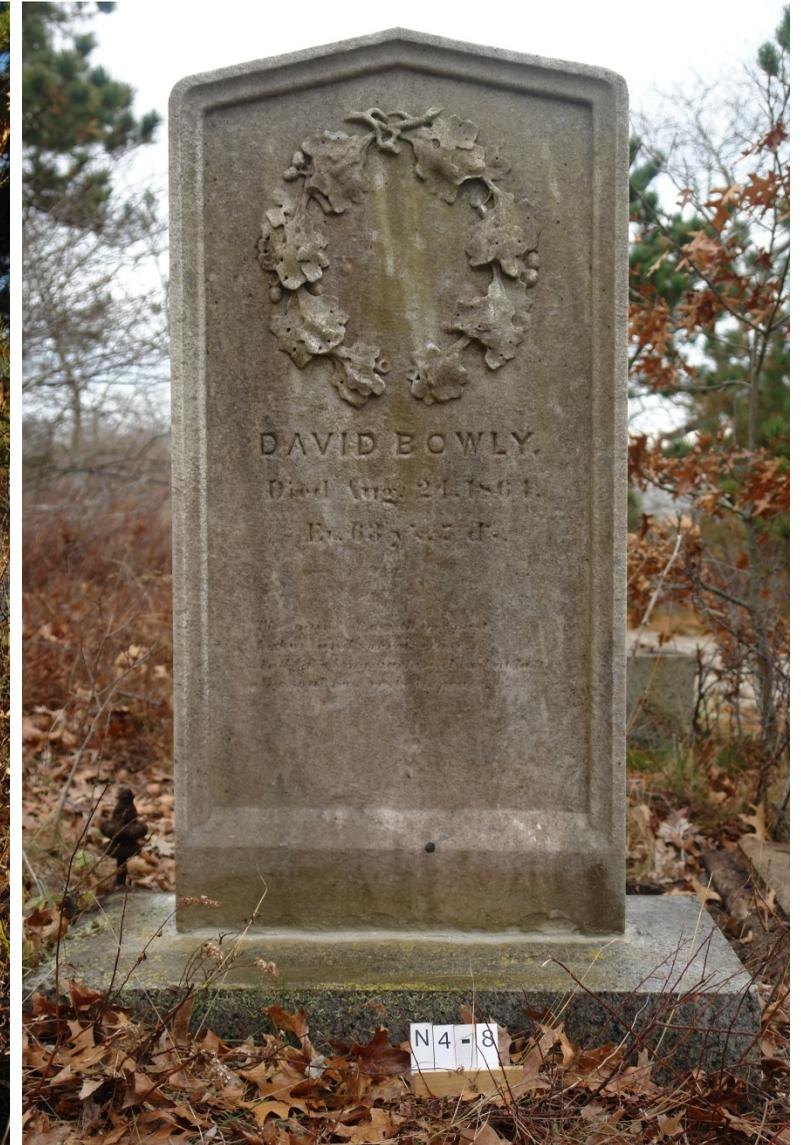
EXISTING CONDITIONS	CONSERVATION STRATEGY
Loose on base Base unit not level	Level base unit Reset headstone to base

Comments: **Buried marble plinth discovered, set behind marker.**

TREATMENT	Date(s) of treatment
<ol style="list-style-type: none"> 1. Soundness of setting joint of marker to base inspected, if found to be unstable, marker removed from base. 2. Area excavated to an appropriate depth removing any roots or large stones. 3. Base is aligned with adjacent markers and re-set level with stone shims 4. Area around base was backfilled with tamped sand and re-graded with existing topsoil 5. Failed mortar removed from setting area and bottom of marker 6. Setting surfaces primed with Acryl 60 diluted 1:3 with water. 7. Marker reset plumb onto base with cement/lime grout (3/2/8) with 000 sand. 8. Excess grout removed and joint area cleaned. 	12/6/2011
