# A Master Conservation Plan for Bas Relief and Bas Relief Park

Provincetown, MA

December 2016

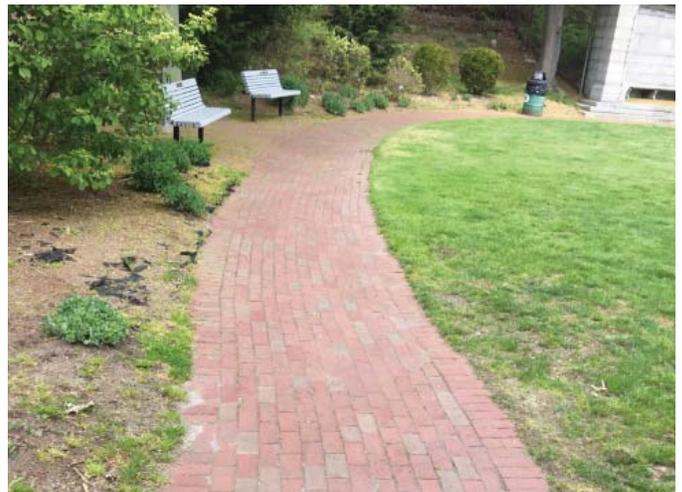
The formalized paths in the park are constructed of dry laid City Hall Paver brick, manufactured by the Styles and Hart Company of Bridgewater, MA. The internal 5' wide brick paths are generally flat and are in fair to good condition with some irregular jointing, delamination, cracking and heaving. Resetting is required. Joint spacing has increased as bricks have moved over the years. Vegetation is growing within some of the joints while others remain voids. Paver edging is not readily evident. This type of paving has a historic appearance, but due to its irregular shape and settlement may not be deemed accessible. Slight projections can become an impediment for poorly sighted individuals.

*Brick Path*

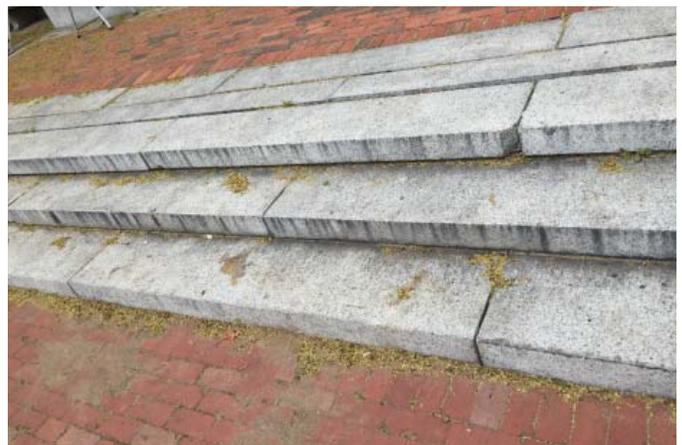
Three granite stairs provide access to the Bas Relief tablet. They exhibit staining, heaving and cracking in a couple of locations. The Bas Relief sits 18" above the park grade and is not ADA accessible. Significant alterations to the historic structure would be required to make the tablet accessible including the addition of ramps or the raising of the grade. This latter alternative would eliminate the stairs. The secondary monuments are accessible and are located to either side of the Bas Relief along the brick pathways.

*Granite Stairs Leading to the Bas Relief*

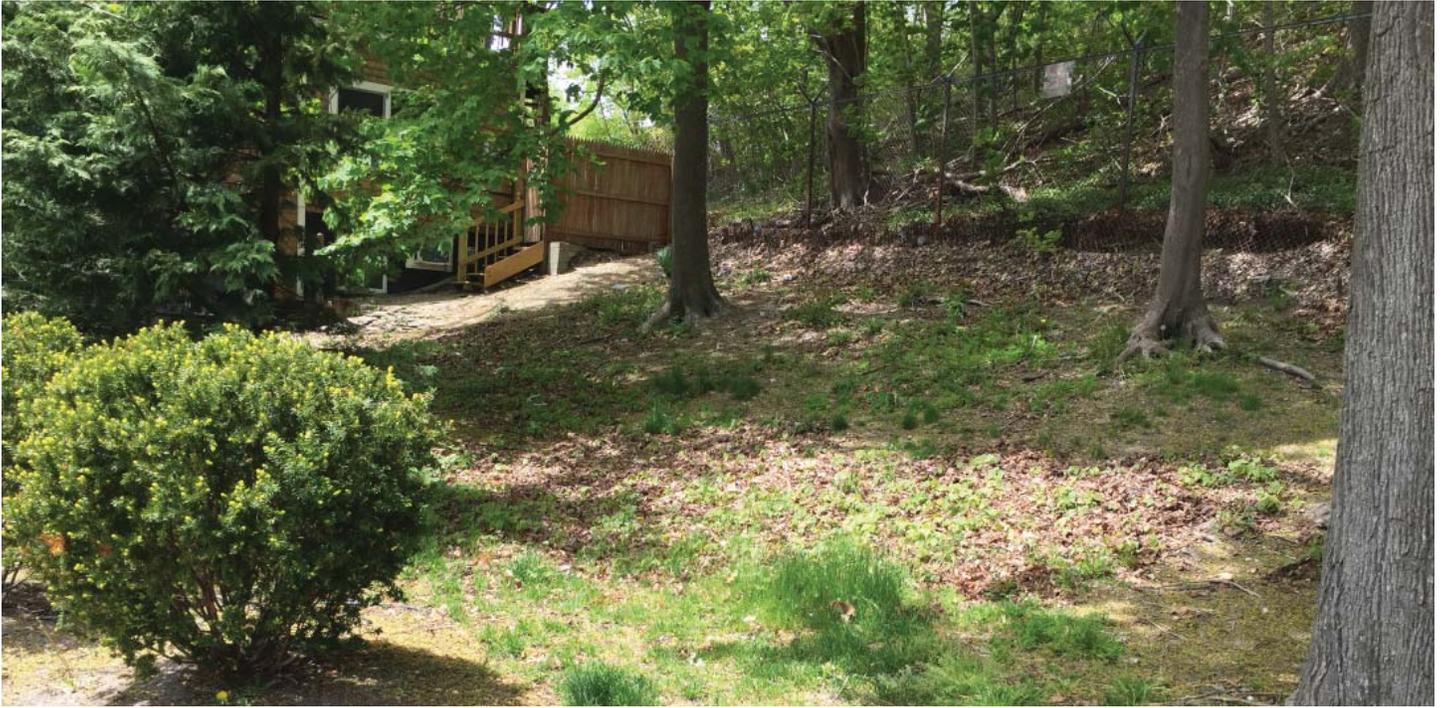
*Base of High Pole Hill at Rear of Bas Relief Park*

Bas Relief Park sits at the base of High Pole Hill. The park is generally flat, but due to the presence of well-draining soils does not exhibit puddling or stormwater runoff problems. The rear portion of the park slopes significantly. The hillside is denuded of vegetation and ground cover due to the lack of sunlight reaching the ground plane caused by dense tree canopies. Sedimentation of the eroded areas sits at the base of the hill. There are no drainage structures evident within the park.

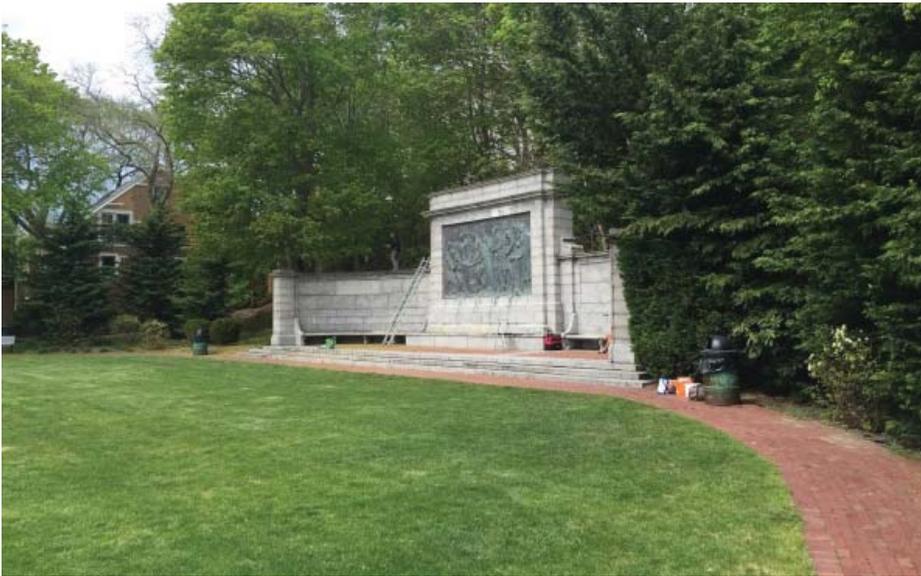
*Central Irrigated Lawn is in Good Condition*

A central irrigated lawn creates a foreground to the Bas Relief and is in good condition. This grass panel, common in a Town Green, should be preserved.

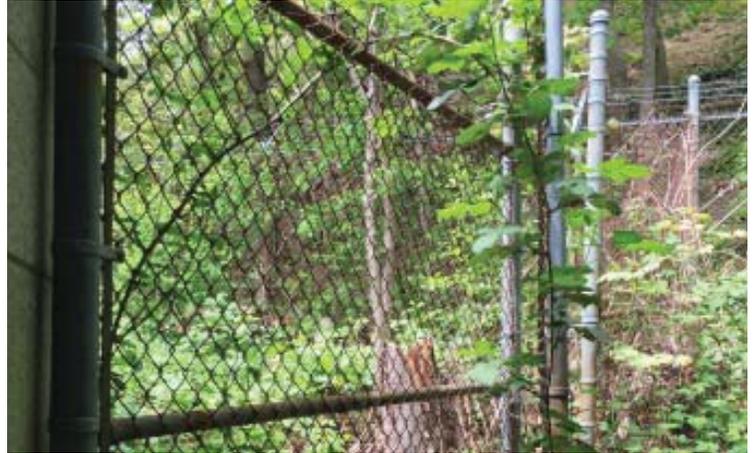
*Chain Link Fence with Barbed Wire*

A 10 foot high chain link fence secures the back property line shared with the Pilgrim Monument. It has a barbed wire topper, is rusty and retains leaves and debris. Two 8 foot high chain link fences in similar condition secure the back of the Bas Relief, with a gate that provides access on the eastern side. These fences are effective in securing the property but are unsightly and do not fit the aesthetic context of a historic park.

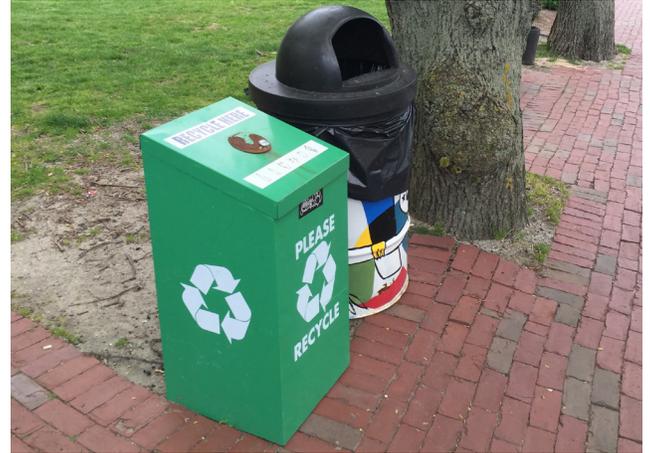
*Recycling Bin & Trash Receptacle*

Oil drums are utilized as trash receptacles. Receptacles along Bradford Street are decoratively painted and are covered with plastic dome lids. Ash urns are 18" vases filled with sand. Recycling bins are fabricated from sheet metal and finished in a bright green color.

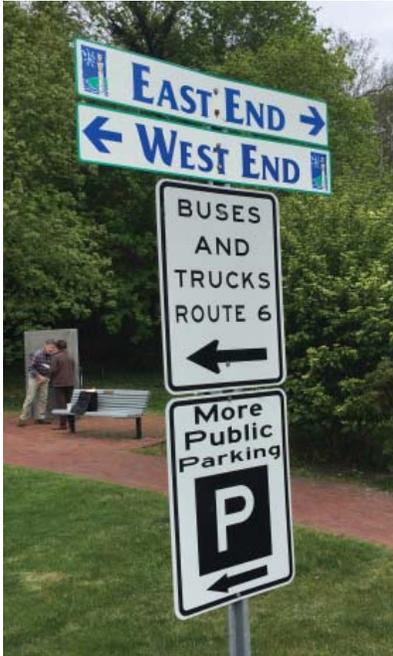
*Variety of signs*

A variety of signs exist within the park including dog regulations, directional signs, public parking locations and truck routes. A wooden sign for the Pilgrim Monument located on their property provides wayfinding for tourists. The park would benefit from a comprehensive signage program that creates consistent design standards, limits the quantity of signs and directs the appropriate location of signs in order to preserve the appearance of the park and views to the Bas Relief.

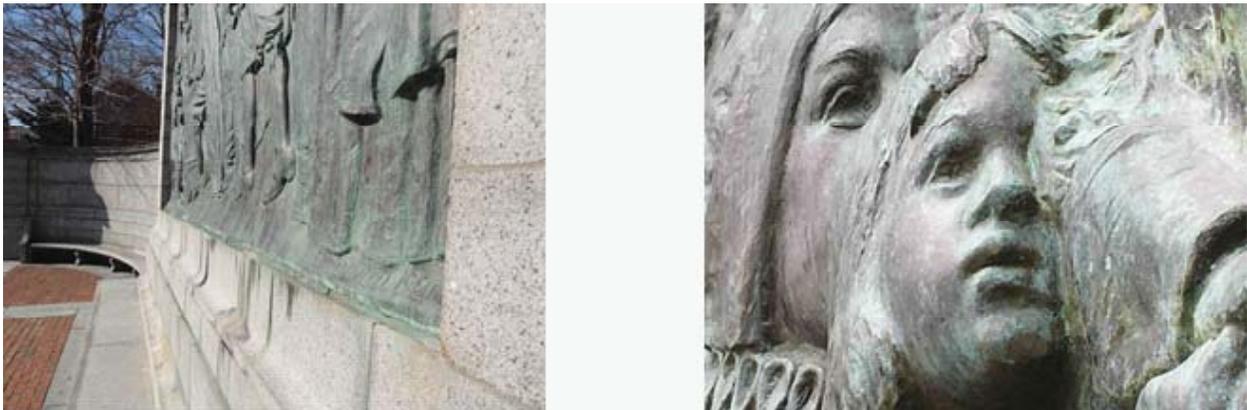
Left: The length of the bronze from the side, showing no bronze deformations. During the site assessment, the conservators tapped the surface every few inches with a steel tool, and no large areas of empty space or loose bronze pins were noted. Right: The side view of the young boy, thought to have been modeled after Dallin's son. Dallin's technique creates a greater illusion of depth by flattening out the face and sculpting details more than halfway around its circumference.

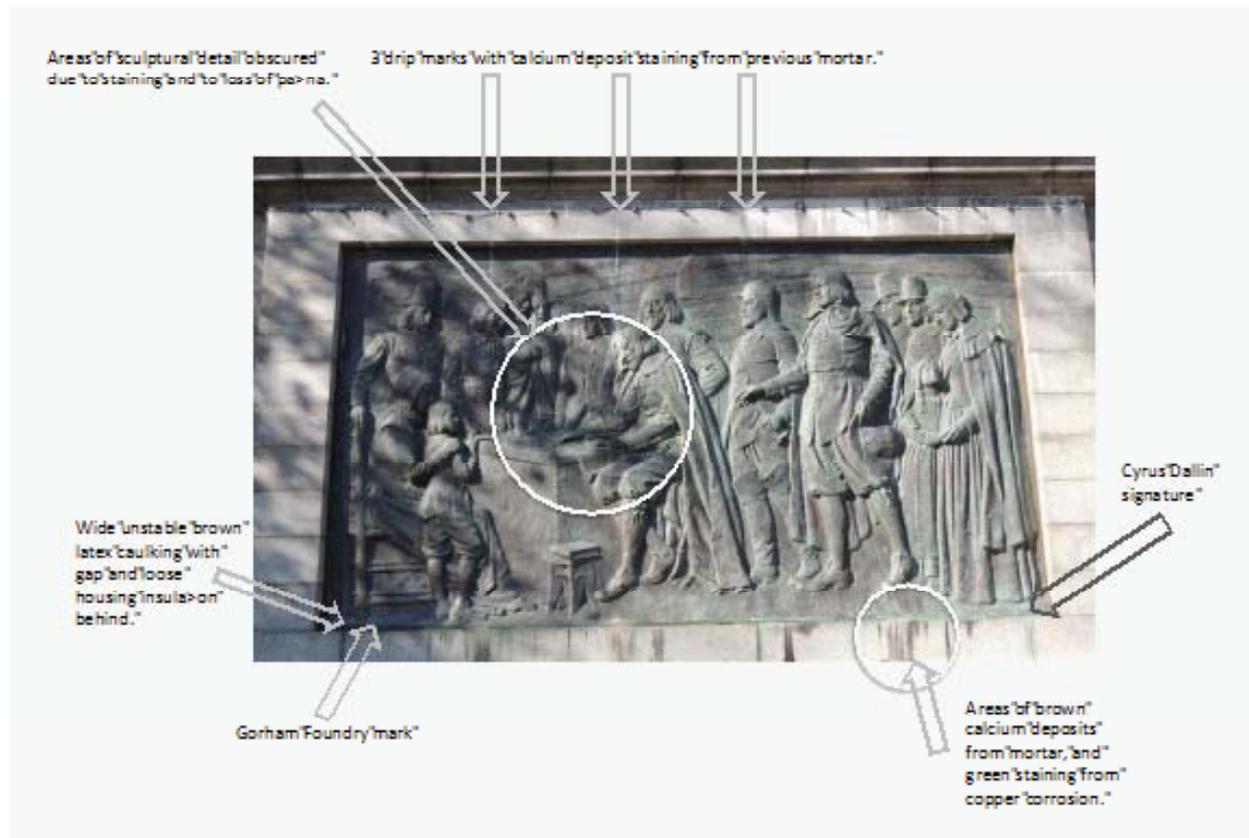
## Diagram of condition notes

The Signing of the Compact is in overall good structural condition, with no cracks or metal deformations. However, the surface has severely suffered from past restorations, including complete overpainting with paint and bronze powders and loss of surface metal from an abrasive cleaning which has obscured some surface detail.

Numerous drip accretions of very hardened calcite from the original limestone mortar joints are present, as are other types of accretions and stains. There is a poor previous attempt at caulking the perimeter of the bronze with brown latex caulk, which is ineffective and unsightly.

There is copper corrosion caused by weather and salt air, including copper chloride (predominantly green-blue from salt), copper sulfate (predominantly green, from air pollution) and copper sulfide corrosion (predominantly black, also from air pollution). These corrosion products have combined with water and caused damage to the granite by staining the blocks and mortar below and adjacent to the bas relief.

The bronze will require careful cleaning, repatination to match the original color, a new protective coating, and a new stable and visually appropriate system of filling the gaps on the perimeter.

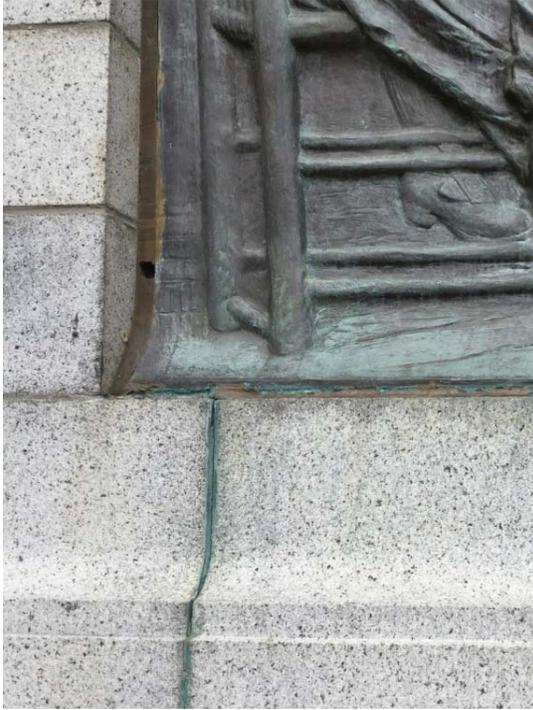
There is a large joint between the bronze bas relief panel and the stone. This joint is currently filled with generations of different materials, including pink house insulation and multiple types of sealant, used to fill the cavity between the two dissimilar materials.

Fig. 16. Large gap at left filled with sealant and insulation. Horizontal joint filled with remnants of oakum and mortar.

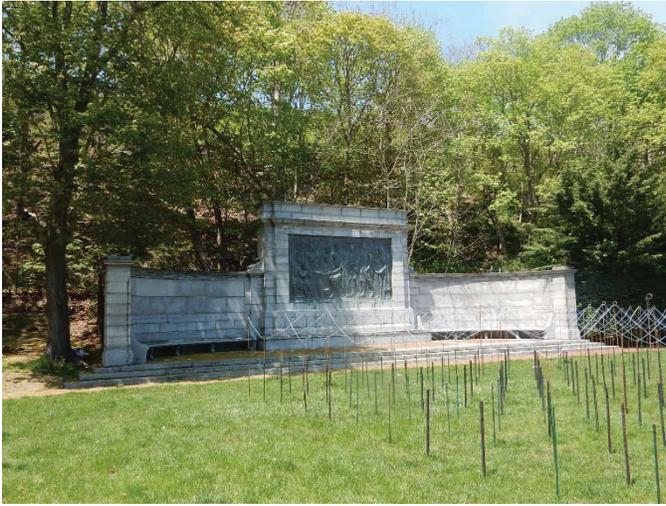
1. Bas Relief viewed from front.

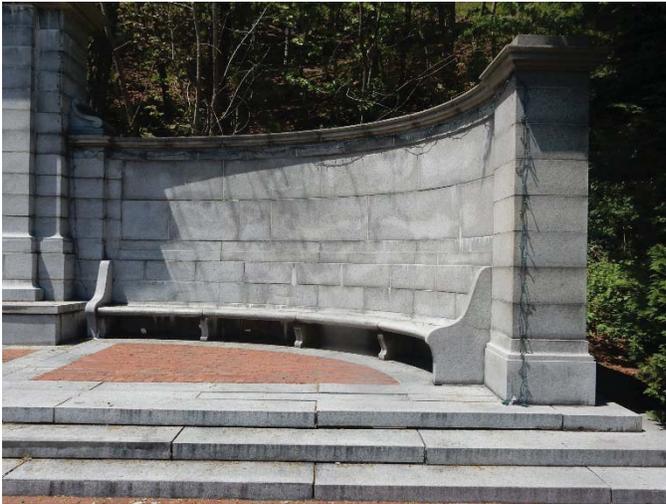
2. Right wing of Bas Relief.

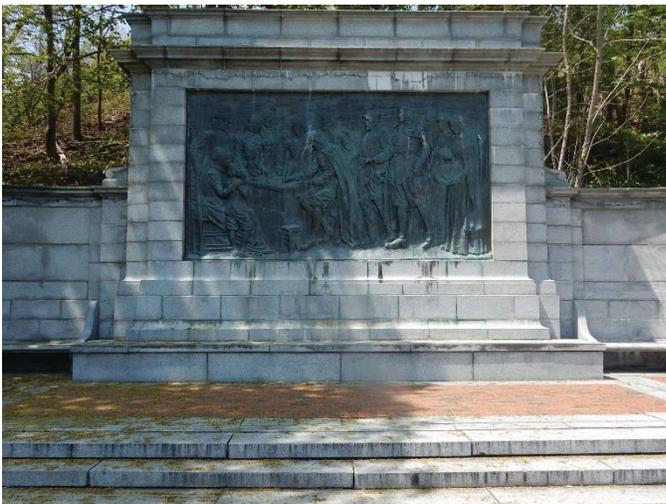
3. Center mass of Bas Relief.

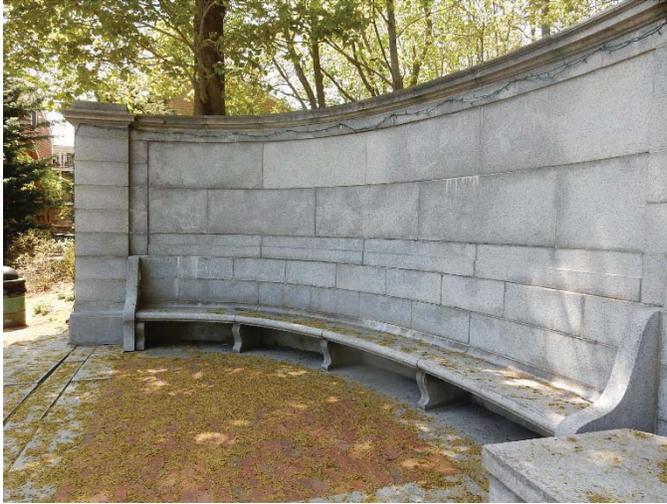
4. Left wing of Bas Relief.

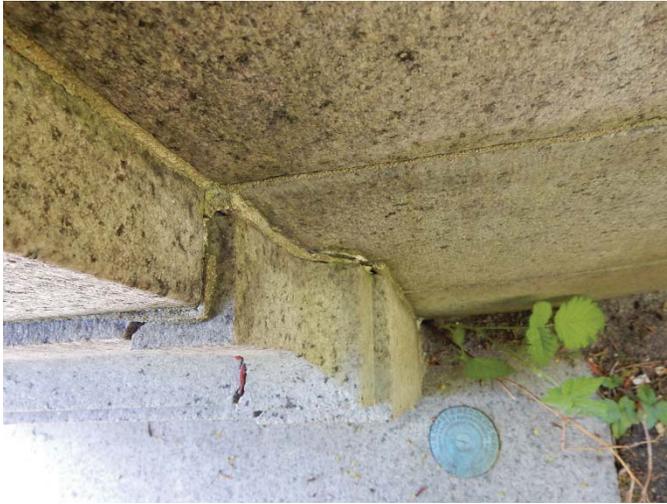
5. U.S. Geodesic Survey benchmark located to the right side of the right wing.

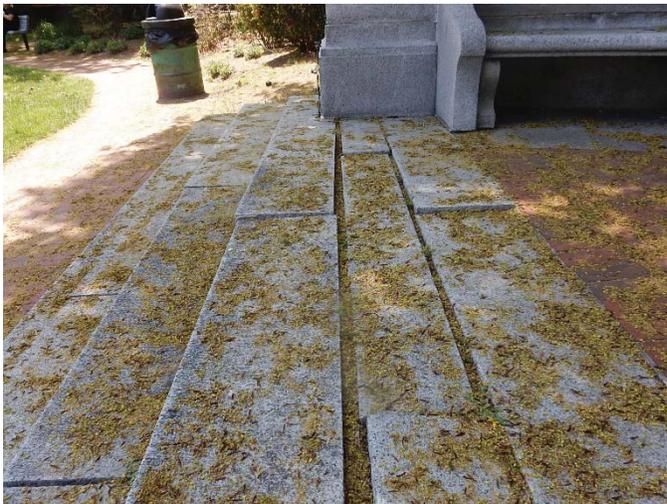
6. View of stair treads and paving looking to the left. Treads have migrated away from the Bas Relief platform. Some heaving is evident.

c. Treads. The stair treads are all dislocated. Remove them all, clean them, and reset in mortar. They may be supported on foundation stones or concrete. Consider rebuilding this support providing anchors to pin treads and pedestals to provide drainage space to remove water between the support and treads. Simply butt the ends together without mortar. Include a stone trench under the walkway to collect water away from the stair support. The problem of grade alignment between stairs and an undulating brick paving raises the question on whether reset stones should be a constant grade or follow that of the brick if the brick is not reset. The scope of replacement should be decided before the final report.

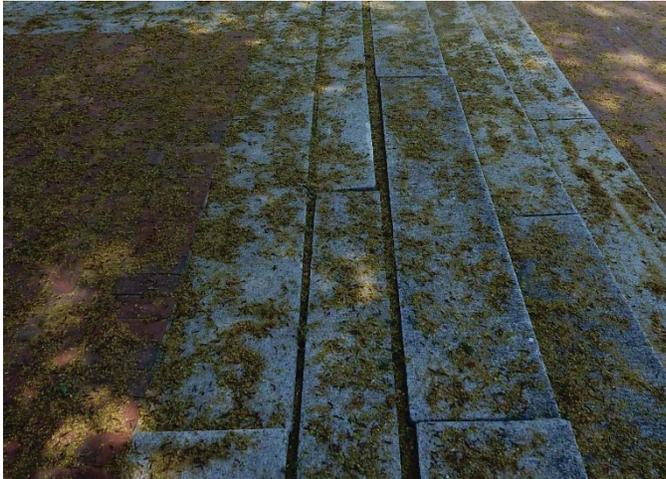
7. View of stair treads and paving looking to the right. Treads have migrated away from the platform. Some heaving is evident.

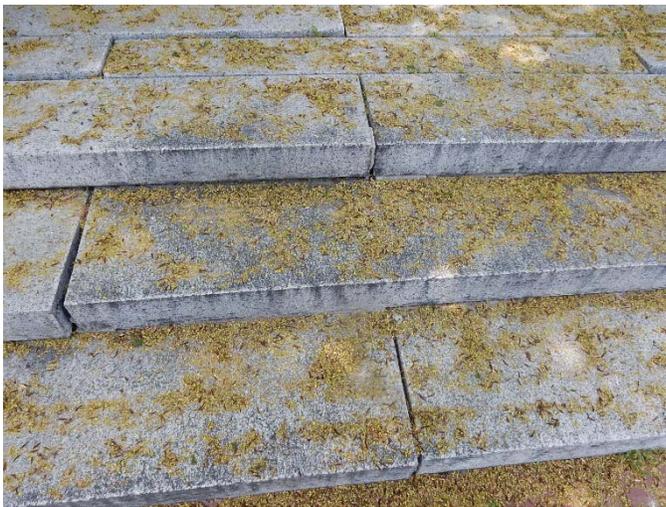
8. Stone treads rising from brick walkway to stone and brick paved platform. Stones have migrated away from the Bas Relief and heaved. Most likely, they are supported on soil that has poor drainage and insufficient compaction.

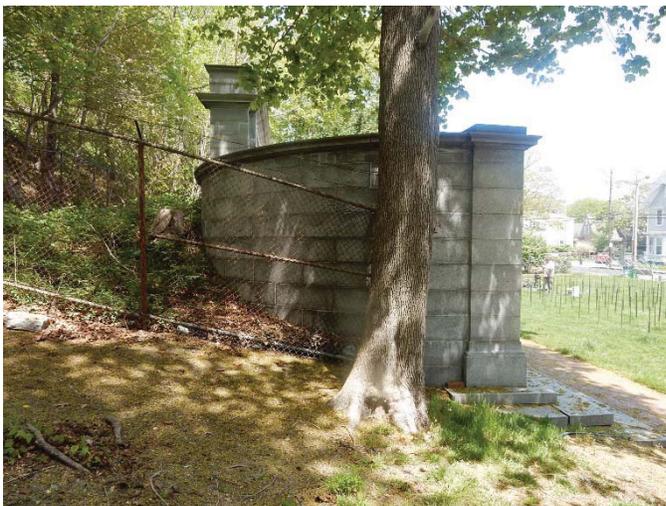
17. View of the left end of the monument. It is at the foot of High Pole Hill. The backside of the Bas Relief is backfilled to align with the slope of the hill.

d. Terrain swale. Surface water running downhill onto the back of the wall can seep into the ground and continue to provide a source of moisture to enter the wall. Regrade the terrain behind the wall to include a swale that diverts runoff around the Bas Relief.

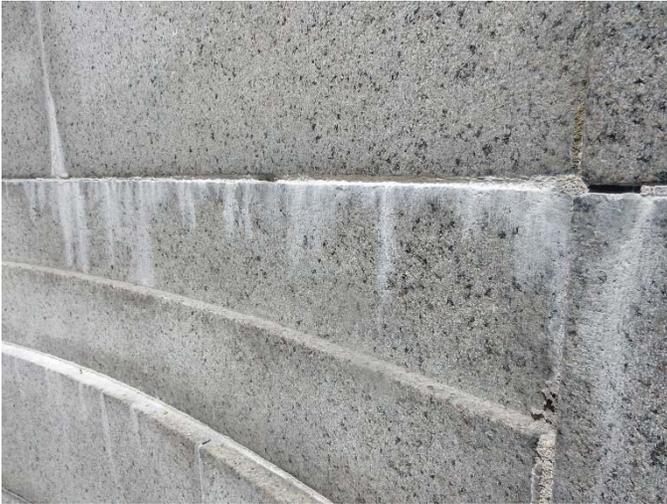
18. Salts bleeding out of mortar joints. The source of the salts is likely from a beach sand or lime mixed in with the cement.

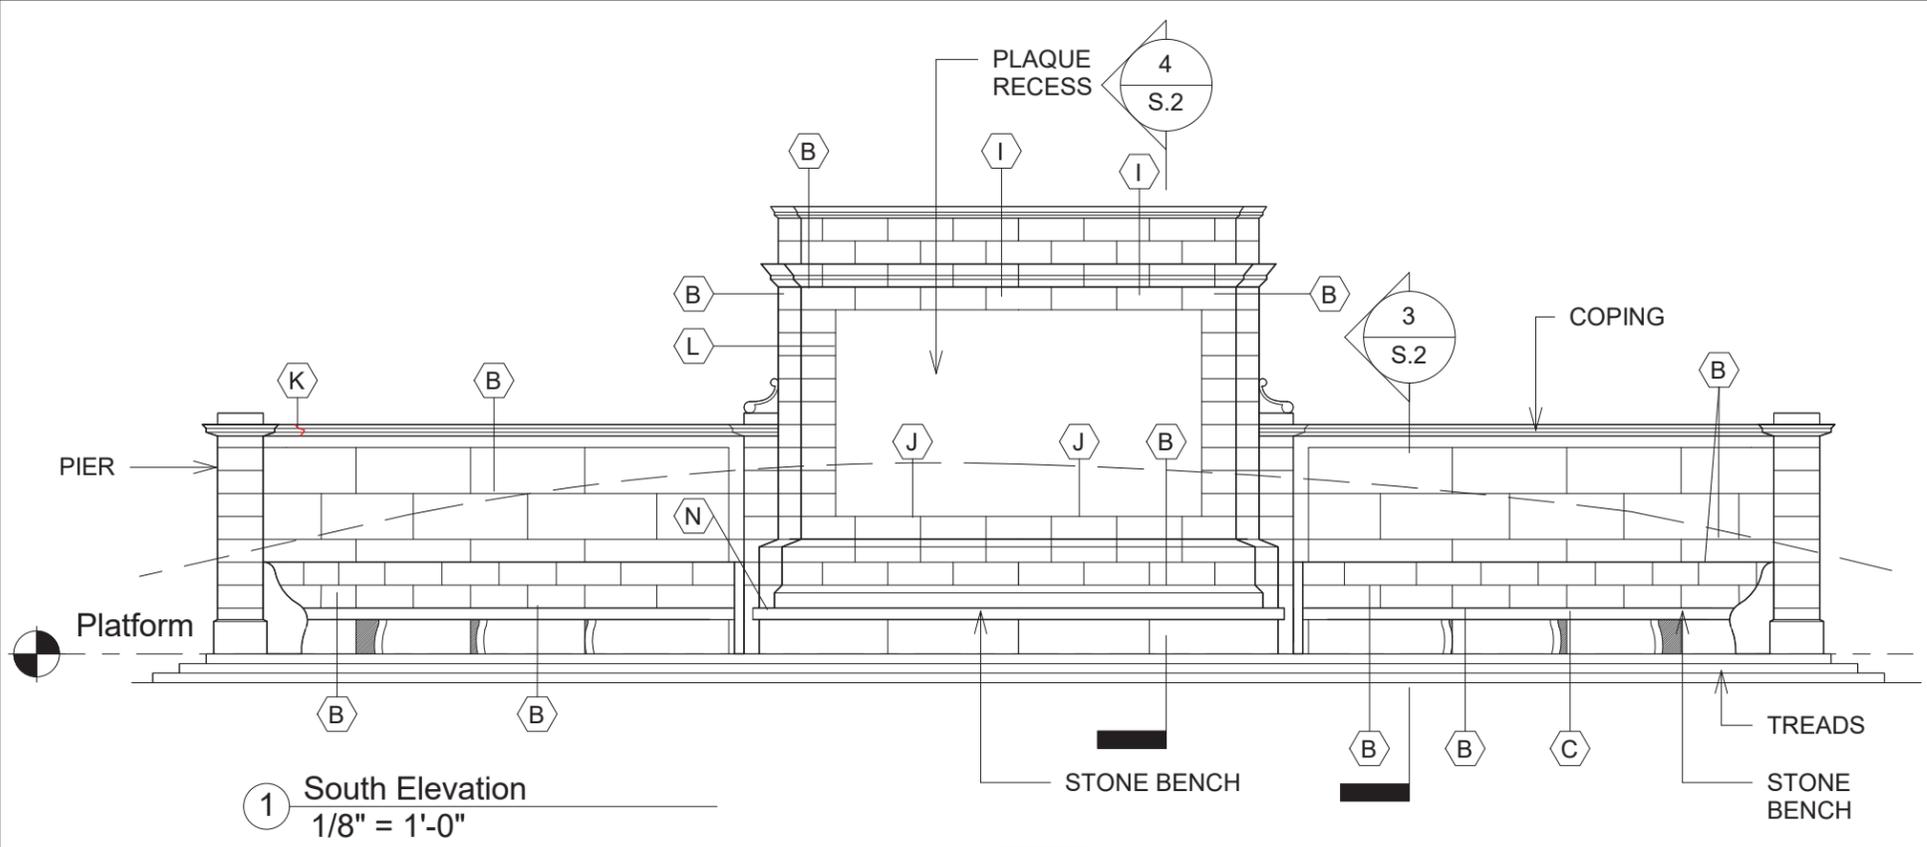
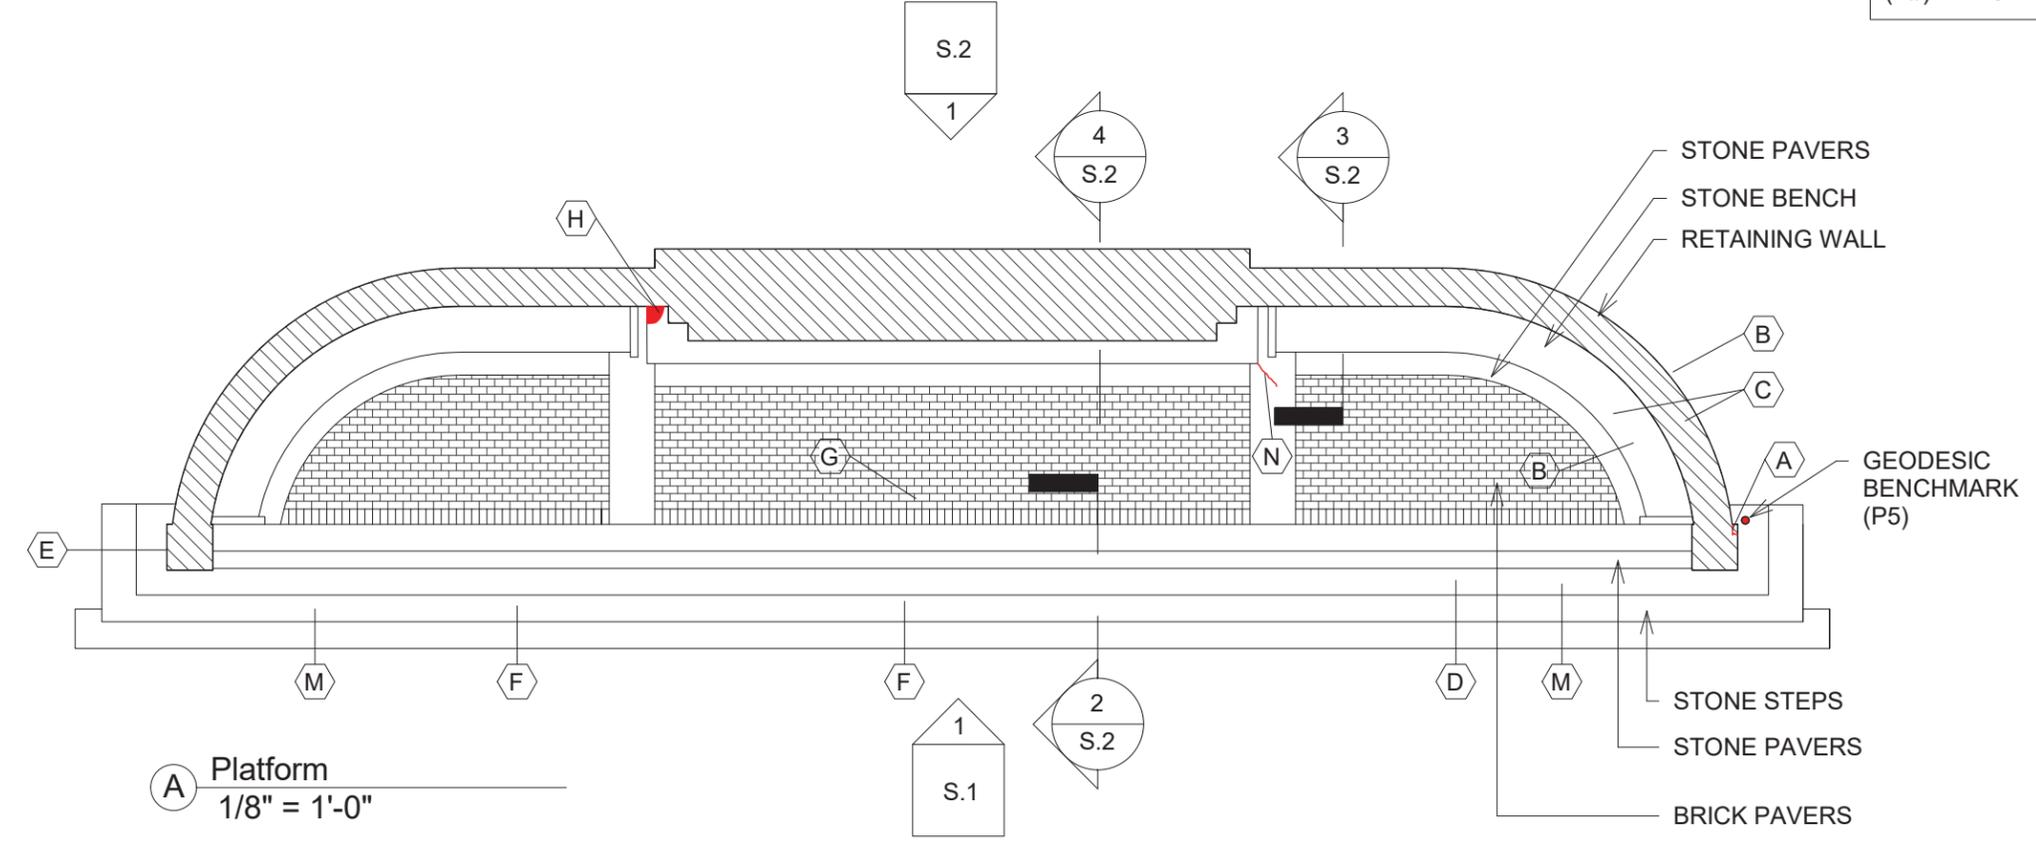
1 South Elevation  
1/8" = 1'-0"

- OBSERVATION KEY NOTES**
- A. CRACK IN WALL BASE. (P16)
  - B. SALTS EMANATING FROM JOINTS. (P18, 20, & 21)
  - C. SEAT/COPING HEAD JOINTS MISSING. (P21)
  - D. HEAD JOINT MORTAR MISSING BETWEEN TREAD SECTIONS. TREADS HAVE MIGRATED AWAY FROM PLATFORM. (P6, 7, & 8)
  - E. LOCAL MOVEMENT IN PILASTER. STONES LIFTED 3/32". WALL BOWED OUT. WALL 5/16" OUT OF PLUMB. (P15)
  - F. STONE TREADS HAVE SETTLED 1/2"±. (P6 & 8)
  - G. BRICK PAVERS HAVE DIPPED.
  - H. CORNER OF CENTER BENCH BROKEN OFF. (P9 & 10)
  - I. STAIN APPEARS AS IF PAINT. (P13)
  - J. COPPER OXIDE STAINS. (P11 & 12)
  - K. CRACKED COPING STONE. (P19)
  - L. SEALANT, NO BACKER ROD, SEALANT ATTACHED TO THREE FACES.
  - M. TREADS DRIFTED 1/2" TO 1". (P6 & 8) CRACKED STONE PAVER. (P14)
- (P#) DENOTES PHOTO NUMBER
